Roof Safety Inspection

The Net Group

TNG-143

35 Spring Gardens, Westminster, London SW1A 2BA, UK

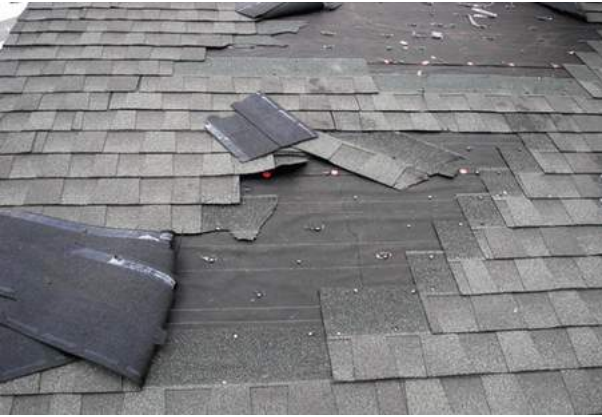
Appendix 1

Question	Response	Details
General Information		Score (5/7) 71.43%
Description of work	Roof repair	
Take a photo

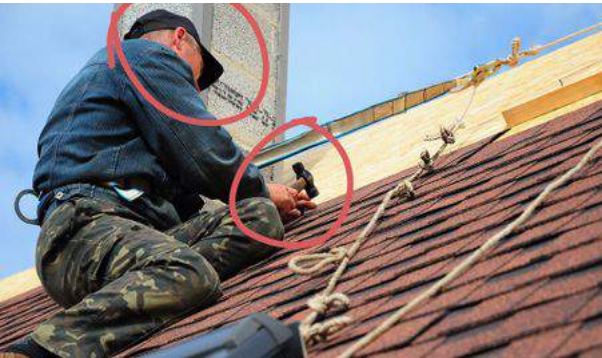
Appendix 3

Have all suitable Personal Protective Equipment been identified and properly worn by workers?	No	No hard hat, protective glasses and gloves
-----------------------------------------------------------------------------------------------	----	--------------------------------------------

<p>Appendix 5</p>		
Do vents/hatches/other openings have guardrails?	N/A	
Are hole gaps in standard distance?	Yes	
Recommendation		Score (0/1) 0.00%
Overall rating	Fail	work on failed responses
Write down recommendations	<ul style="list-style-type: none"> - Signage should be visible to your work area to let others know their restriction - Wear the proper PPE - Mark on skylights, workers may accidentally step on them or trip on the edges

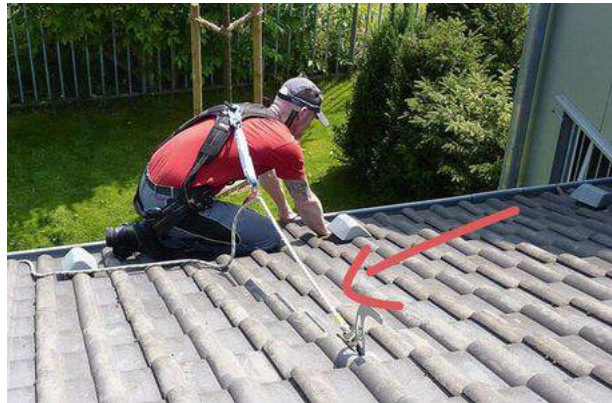
Appendix 4

Question	Response	Details
Are roof edges protected?	No	Open edges but you can use harness to reach roof gutter

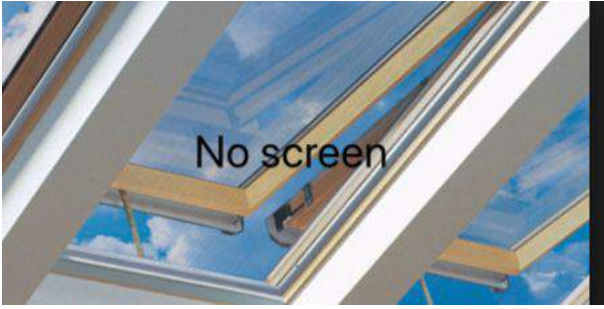
Appendix 5

<p>Appendix 4</p>		
Are guard rails/parapets present?	Yes	
Are pre-installed anchorages available?	Yes	
Are Harnesses and Lanyards available and inspected?	Yes	
Are Harnesses and Lanyards properly attached to anchorages?	Yes	
Openings		Score (1/2) 50.00%
Do skylights/other openings have screens?	No	Skylight is open and doesn't have screen
