Trench or Excavation Daily Inspection

EXC-482201

Ridgemont Drainage System

1419-1421 Ridgemont Dr, Austin, TX 78723, USA

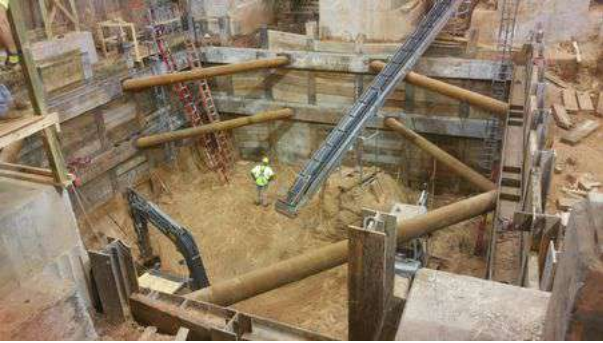
Appendix 1

Question	Response	Details
Excavation Information		
Excavation project description	This excavation project is for erecting a building.	
Purpose of Trenching	Drainage	
Excavation Depth	20 ft	
Excavation Width	15 ft	
Take photo of the excavation area

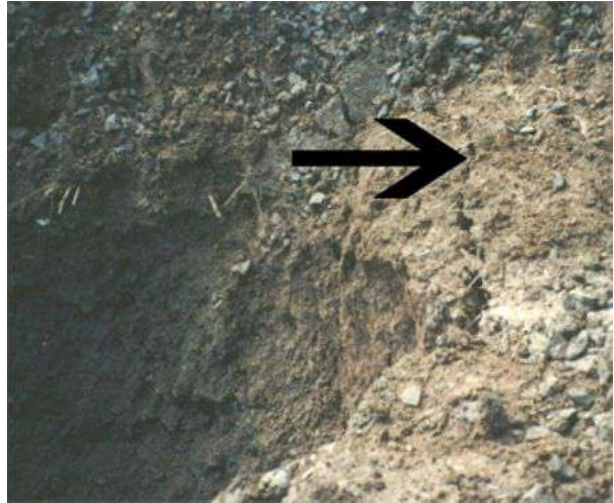
Appendix 2

Question	Response	Details
Surface encumbrances removed or supported.	No	Fissures are visible on the side
<div data-bbox="92 284 308 501" data-label="Image"> </div> <div data-bbox="140 506 256 533" data-label="Caption"> <p>Appendix 2</p> </div>		
<p>REFERENCE: No encumbrances like utilities, foundations, streams, water tables, transformer vaults, walkways, bridges, roads, and geologic anomalies present [This is an example of how you can use iAuditor to include best practice reference images in your templates to assist with inspections]</p> <div data-bbox="533 752 1059 1550" data-label="Image"> </div>		
Spoils, materials, and equipment set back at least two feet from the edge of the excavation.	Yes	
Barriers provided at all remotely located excavations, wells, pits, shafts, etc.	Yes	
Walkways and bridges over excavations four feet or more in depth are equipped with standard guardrails and toeboards.	Yes

#1. A fissure was detected. Please relocate the excavation immediately.

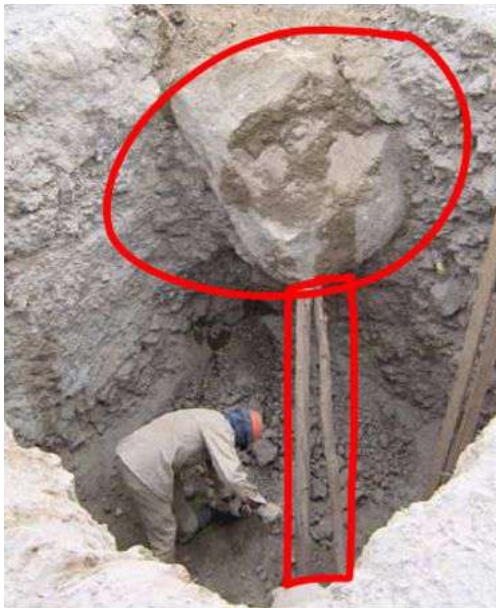
Appendix 3

Question	Response	Details
Warning system established and utilized when mobile equipment is operating near the edge of the excavation.	Yes	
Employees protected from loose rock or soil that could pose a hazard by falling or rolling into the excavation.	No	Rock on top of the worker might collapse. Support system used is not adequate.

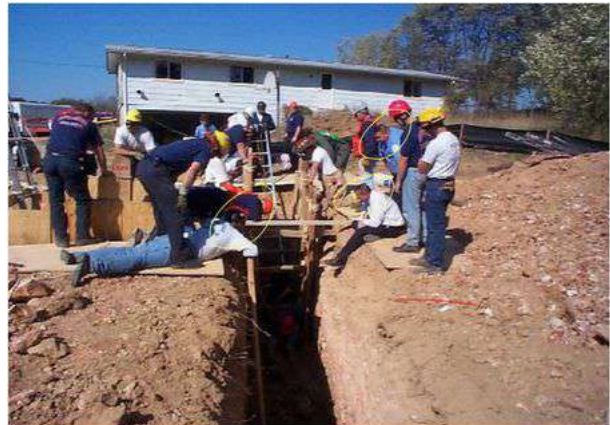
Appendix 4

<p data-bbox="140 680 256 707">Appendix 3</p>		
Employees required to stand away from vehicles being loaded or unloaded.	Yes	
Employees prohibited from going under suspended loads.	Yes	
Employees prohibited from working on the faces of slopes or benched excavations above other employees.	Yes	
Hard hats worn by all employees.	No	Some workers do not use hard hats

#2. Wear hard hats at all times during the operation.

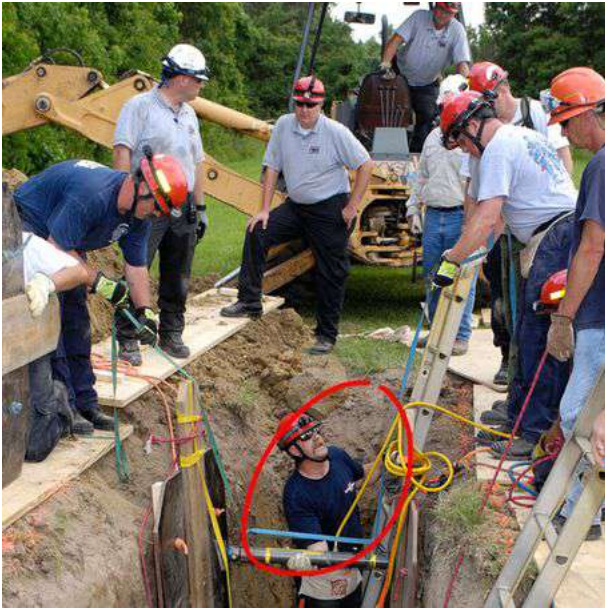
Appendix 5

<p data-bbox="140 1404 256 1431">Appendix 4</p>		
Warning vests or other highly visible clothing provided and worn by all employees exposed to public vehicular traffic.	No	Some workers do not wear warning vests.

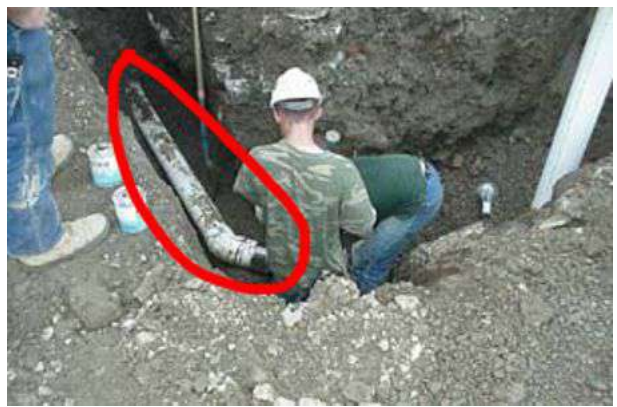
Appendix 8

<p data-bbox="140 577 256 607">Appendix 7</p>		
Water removal equipment monitored by a competent person.	Yes	
Surface water or runoff diverted or controlled to prevent accumulation in the excavation.	Yes	
Inspections made after every rainstorm or other hazard-increasing occurrence.	Yes	
Hazardous Atmosphere		Score (6/7) 85.71%
Atmosphere within the excavation tested where there is a reasonable possibility of an oxygen deficiency, combustible or other harmful contaminant exposing employees to a hazard.	No	A gas pipe was found upon excavation.

#3. Be cautious this might cause respiratory hazards due to toxic gas.
