Home Inspection Checklist

4003 Paloma Cir, Austin, TX 78734, USA

24 Oct 2018 05:52 PM

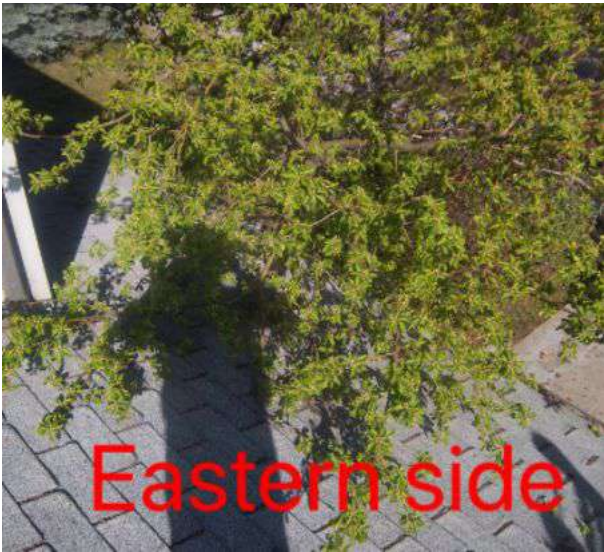
Appendix 1

| Question | Response | Details |
|--|---|---|
| No branches or bushes touching the house or overhanging the roof | No | Tree on the eastern side of the house is overhanging the roof. |

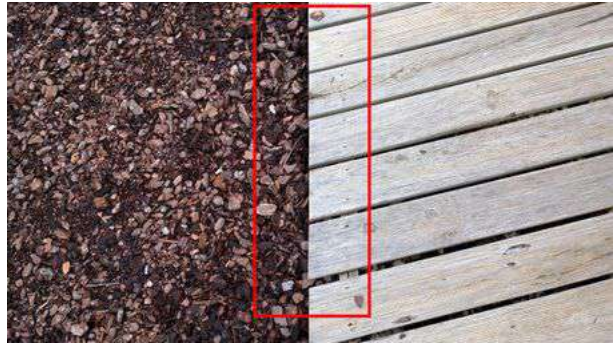
Appendix 2

| Question | Response | Details |
|--|---|---|
| Adequate clearance between ground and wood siding materials; no wood-to-earth contact | No | Clearance not adequate. No wood to earth direct contact but almost touching. |

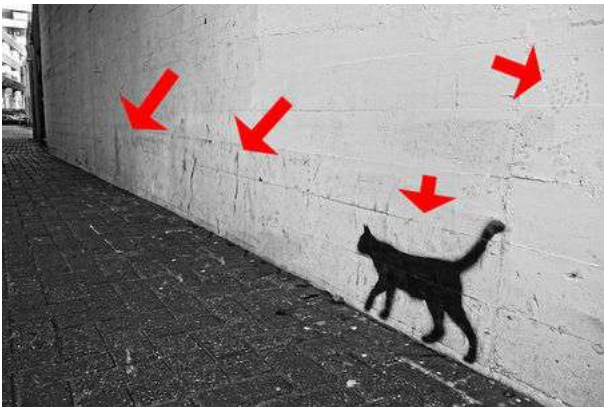
Appendix 3

| Question | Response | Details |
|--|---|---|
| No stains on exterior surfaces | No | At the back of the house is this painting of a cat and the noticeable shoe print apart from the stains on the white wall. |

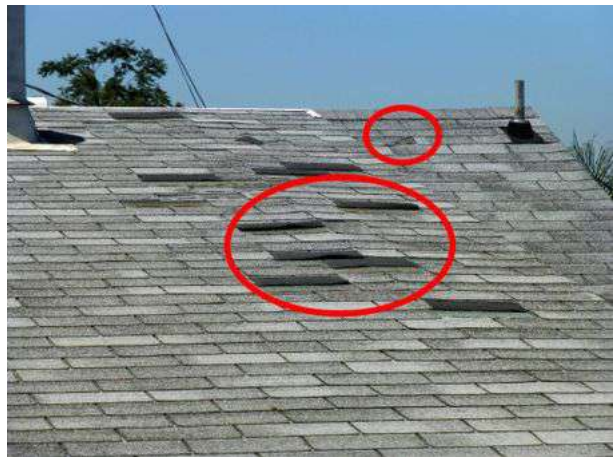
Appendix 4

| Question | Response | Details |
|---|---|--|
| <p>Composition tiles / shingles: no curling, no cupping, no loss of granulation particulate, no broken, damaged or missing shingles, no more than two layers of roofing</p> | <p>No</p> | <p>South side roof show signs of curling and damage.</p> |

| Question | Response | Details |
|---|---|---|
| Composition tiles / shingles: no curling, no cupping, no loss of granulation particulate, no broken, damaged or missing shingles, no more than two layers of roofing | No | South side roof show signs of curling and damage. |
