Electrical Installation Condition Report

J.S. Francisco

Electrical Installation Certificate No.
EICR2208

Location
203 W 14th St, Casper, WY 82601, USA

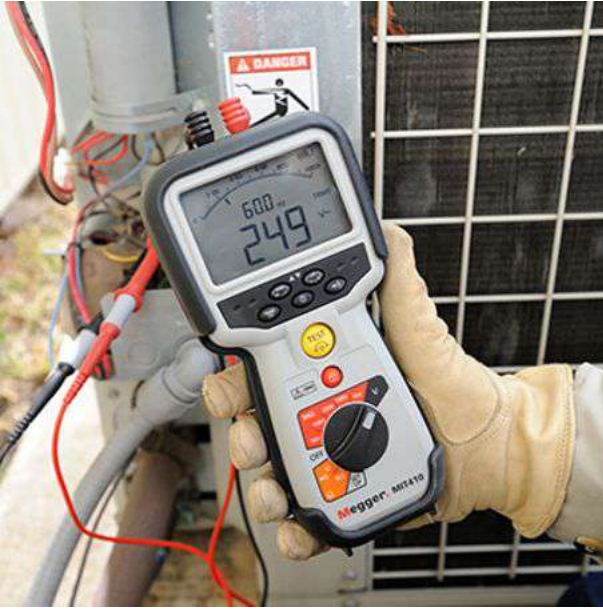
Appendix 1

<p data-bbox="140 750 256 779">Appendix 1</p>		
Description	low resistance reading	
Photo 2		
Take a photo of any significant information (e.g. faulty wires, damaged equipment, etc)

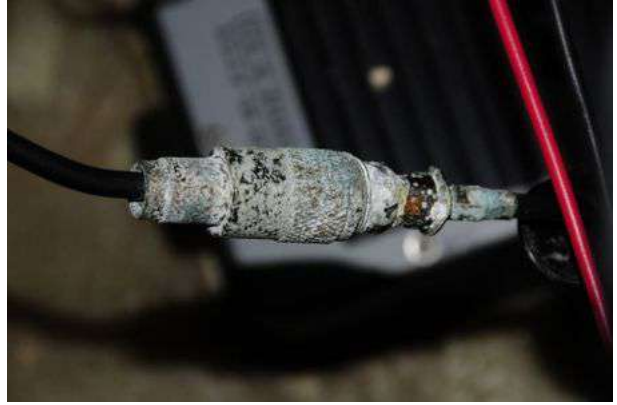
Appendix 2

<p data-bbox="140 1265 256 1294">Appendix 2</p>		
Description	Faulty wires	
Photo 3		
Take a photo of any significant information (e.g. faulty wires, damaged equipment, etc)

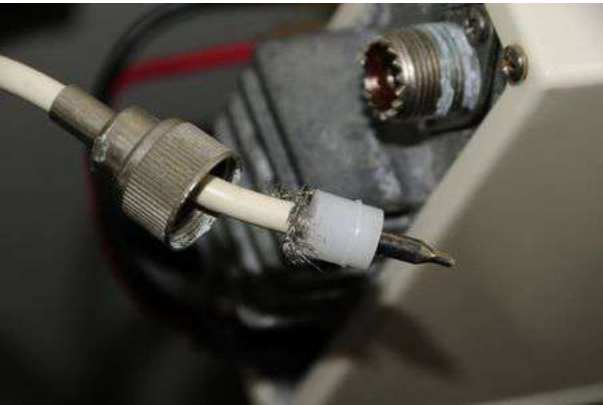
Appendix 3

<p data-bbox="140 1783 256 1812">Appendix 3</p>		
Description	Faulty wires	
Photo 4

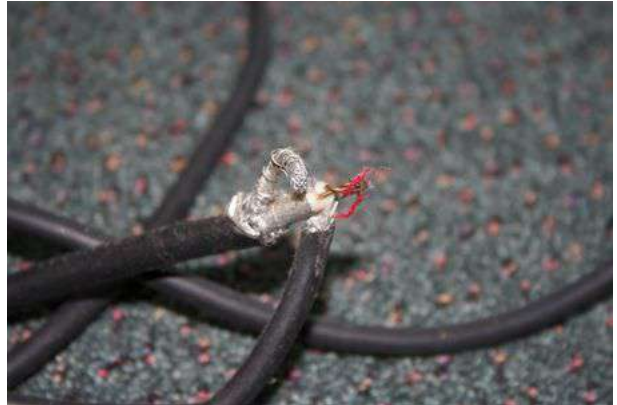
Appendix 4

</div> <p data-bbox="140 472 256 499">Appendix 4</p>			
Description		Faulty wires	
Completion			
Reviewed and confirmed by (Full Name and Signature of Qualified Supervisor of the Approved Contractor)	George Furnace	17 Oct 2018 05:49 PM
