# Racking Inspection Checklist

## SVC Warehouse

14 Feb 2019 03:18 PM

3485 Broadway Avenue, Chattanooga, Tennessee 37415

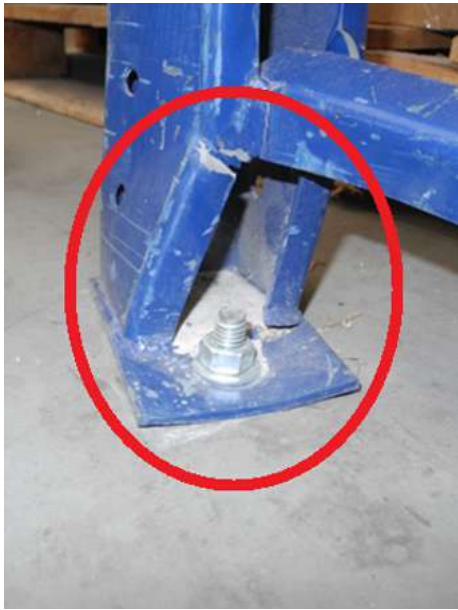
Appendix 1

Question	Response	Details
Take photos of the damage and identify risk level	Amber risk (significant damage)	13mm twisted base plate, no shims installed

Question	Response	Details
<b>Racking Inspection Checklist</b>		Score (4/8) 50.00%
Specify the location of the damaged rack by tapping ADD AREA.		
AREA 1		
Aisle	02	
Bay Number	01-3-2	
What component of the racking system is damaged?	Beam	
Which part/s of the beam is/are damaged?	Rear beam, Rear clips	
Take photos of the damage and identify risk level	Green (minor damage)	5mm damage to entire beam length. Safe for now, but reassess at next inspections.
AREA 2		
Aisle	03	
Bay Number	03-1-5	
What component of the racking system is damaged?	Frame	
Which part/s of the frame is/are damaged?	Rear base plate	
Take photos of the damage and identify risk level	Amber risk (significant damage)	13mm twisted base plate, no shims installed
<div style="text-align: center;">

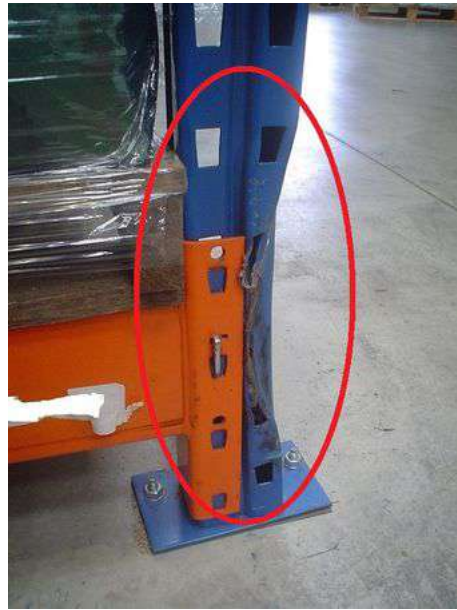
Appendix 2

<p data-bbox="140 707 256 734">Appendix 1</p>		
Take photos of the damage and identify risk level	Red risk (critical damage)	Side impact is over 10mm, no front upright guard installed

Question	Response	Details
Bay Number	02-2-3	
What component of the racking system is damaged?	Frame	
Which part/s of the frame is/are damaged?	Bracing	
Take photos of the damage and identify risk level	Green (minor damage)	
AREA 4		
Aisle	07	
Bay Number	01-2-1	
What component of the racking system is damaged?	Frame	
Which part/s of the frame is/are damaged?	Front uprights	
Take photos of the damage and identify risk level	Red risk (critical damage)	Side impact is over 10mm, no front upright guard installed

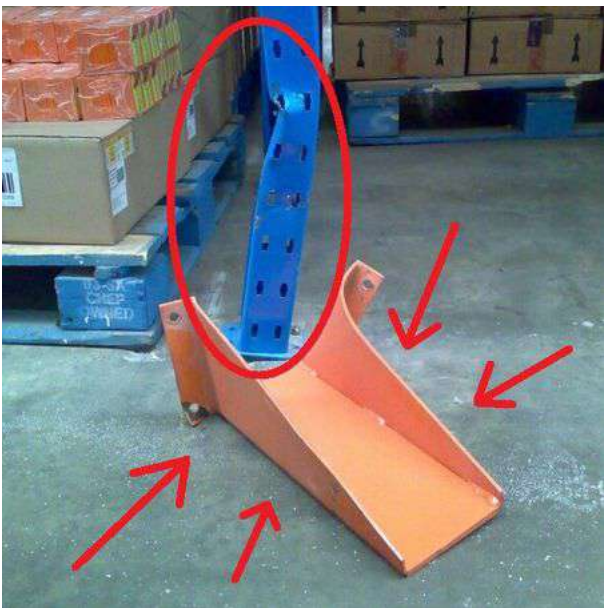
Appendix 3

<p data-bbox="140 1155 256 1182">Appendix 2</p>		
Take photos of the damage and identify risk level	Red risk (critical damage)	
Take photos of the damage and identify risk level	Red risk (critical damage)	The detached rear upright guard and missing anchor bolts are also a slip, trip, and fall hazards!

<p>Appendix 2</p>		
AREA 5		
Aisle	07	
Bay Number	02-1-1	
What component of the racking system is damaged?	Accessory, Frame	
Which part/s of the frame is/are damaged?	Front shims, Front uprights	
Take photos of the damage and identify risk level	Red risk (critical damage)

Question	Response	Details
Which part/s of the accessory is/are damaged?	Upright Guards	
Take photos of the damage and identify risk level	Red risk (critical damage)	The detached rear upright guard and missing anchor bolts are also a slip, trip, and fall hazards!

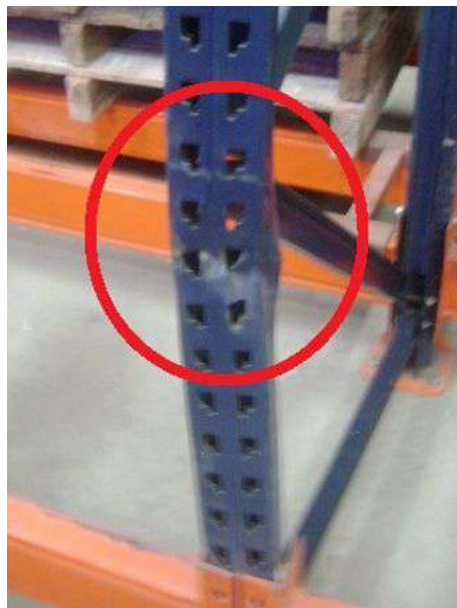
Appendix 4

Question	Response	Details
Take photos of the damage and identify risk level	Amber risk (significant damage)	8mm side impact to rear upright

<p>Appendix 3</p>		
AREA 6		
Aisle	08	
Bay Number	03-4-2	
What component of the racking system is damaged?	Beam	
Which part/s of the beam is/are damaged?	Front clips, Rear clips	
Take photos of the damage and identify risk level	Green (minor damage)	Reassess at future inspections.
AREA 7		
Aisle	08	
Bay Number	01-1-3	
What component of the racking system is damaged?	Frame	
Which part/s of the frame is/are damaged?	Rear uprights

Question	Response	Details	
Take photos of the damage and identify risk level	Amber risk (significant damage)	8mm side impact to rear upright
