Pressure Vessel Inspection Checklist (Unfired) Conducted on 11th Apr, 2019 By SafetyCulture Staff

Inspection score	Failed items	Created actions
89.47%	4	0
Conducted on 📅 11th Apr, 2019 ⌚ 3:23 PM +08		
Prepared by Bernard F		
Location San Jose, CA 95135 United States (37.3084816473777, -121.6406824504114)

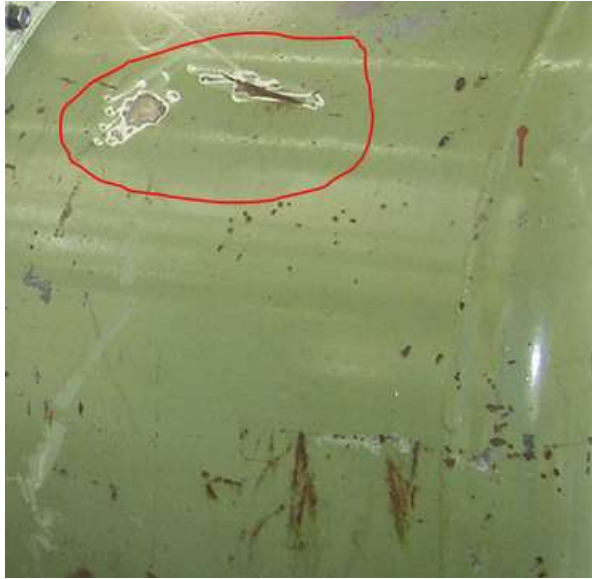
Visible dent observed. Urgent need of repair.

Found cut. Initial assessment is for repair only but will determine if need to be replaced after test.

Photo 1	
Determine if should be repaired or replaced

Comments
Found a cut and a dent. Will conduct test to determine if can be salvaged by repair or needs replacement. If can still be repaired, will proceed with reapplication of corrosion resistant coating on vessel and piping.
Inspector Name and Signature

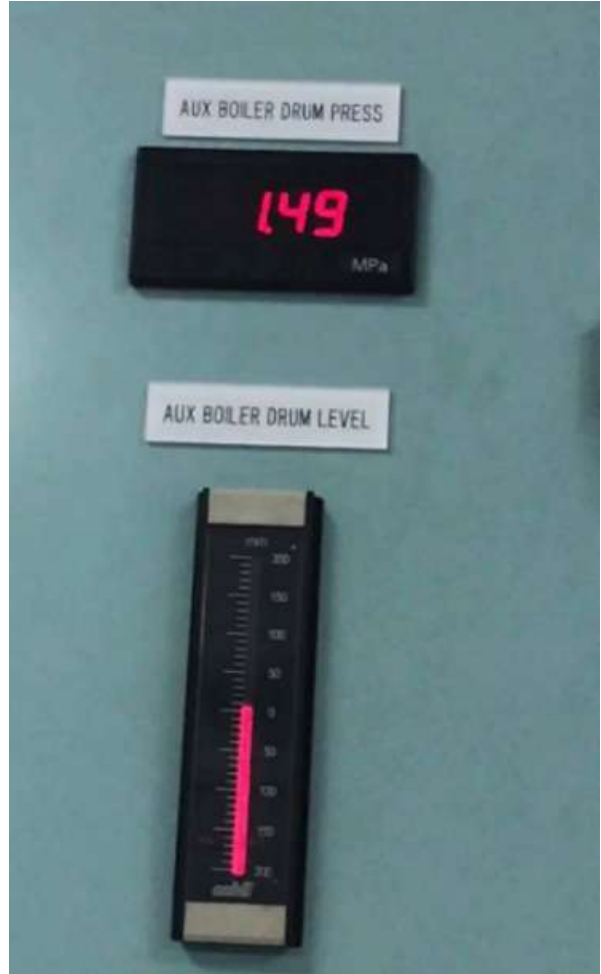
Photo 2

The following steps should be performed for each safety device:	
<p>IMPORTANT: The set pressure is not higher than the maximum allowable working pressure (MAWP) marked on the pressure retaining item?</p>	Yes
<p>Photos</p>

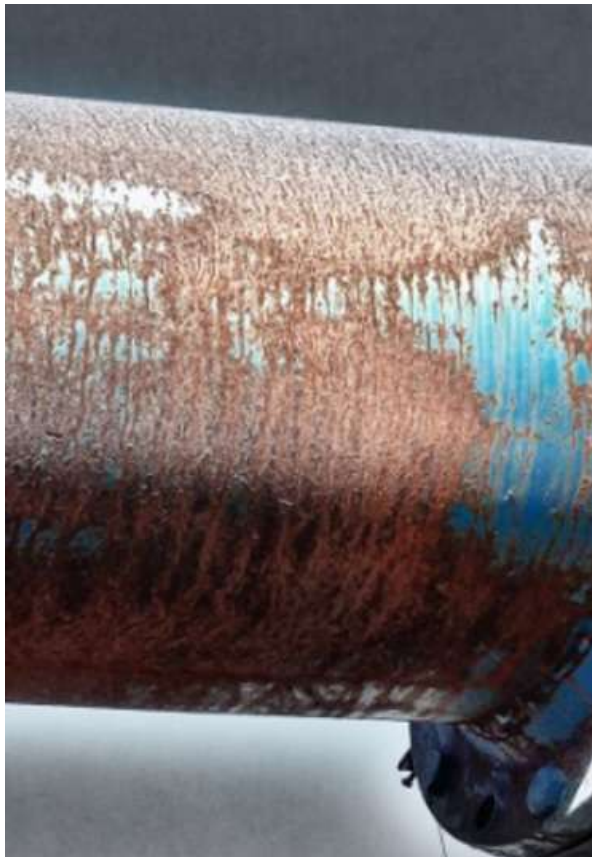
No evidence of corrosion, erosion, or cracking or other detrimental conditions?

Photo 3	
Pressure Gages - pressure indicated by the required gage should be compared with other gages on the same system.
