16 Apr 2019 / EECU322406 / Expert Exporters Co.

ISO Container Inspection Checklist Conducted on 16th Apr, 2019 By SafetyCulture Staff

Inspection score	Failed items	Created actions
87.67%	9	3
Site Sydney		
Shipper Expert Exporters Co.		
Country of Origin United States of America		
Container Number EECU322406		
Inspected by Sabrina Diaz		
Conducted on 📅 16th Apr, 2019 ⌚ 12:18 PM +08

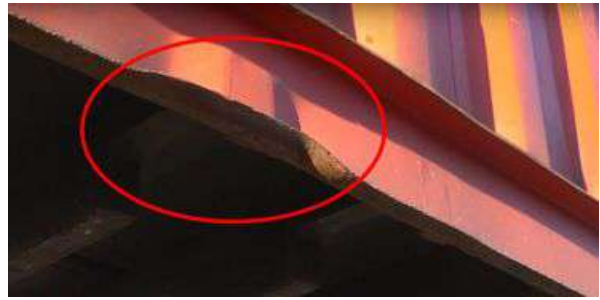
Photo 2

Bottom side rails

Fail

Follow up condition of undercarriage side rail on next ISO container inspection (possible need for repair)

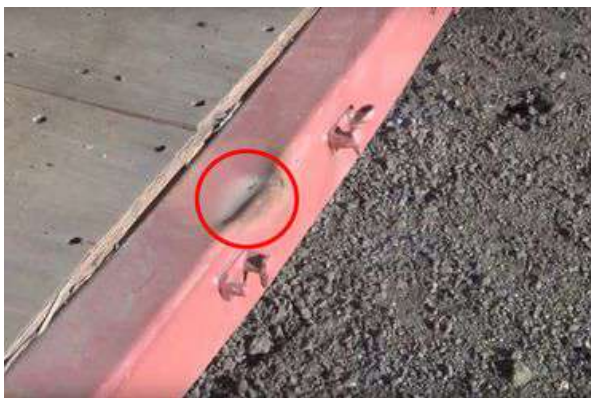
Photo 5

Door sill

Fail

Monitor minor damage

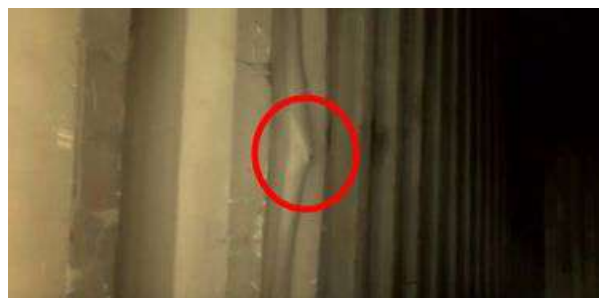
Photo 6

Vertical plate

Fail

To Do Coordinate with maintenance personnel and arrange for the repair of this part before packing

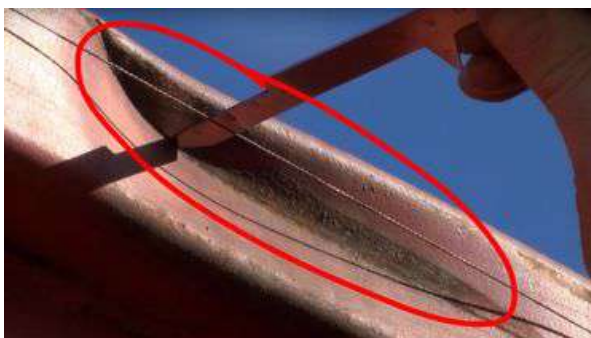
Photo 7

Top side rail

Fail

Monitor minor damage

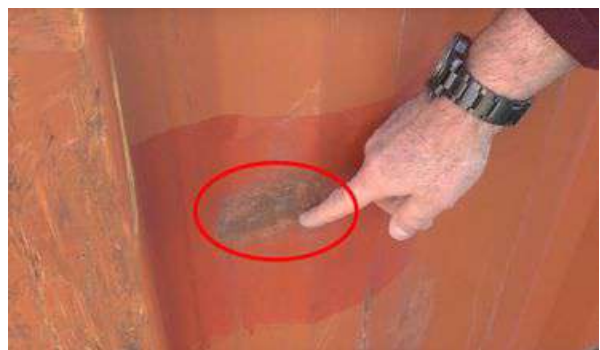
Photo 8

Panel

Fail

Contain small area of corrosion before it spreads

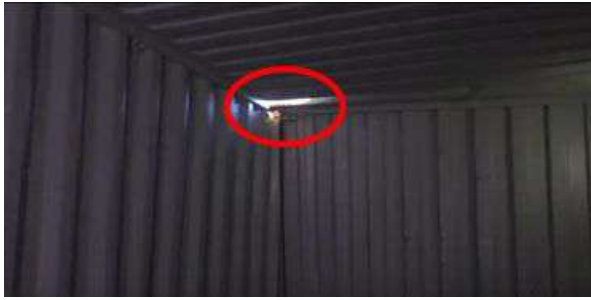
Photo 9

Light leak

Fail

Make sure to repair this part of the roof near the front wall before packing cargo and take photos when done

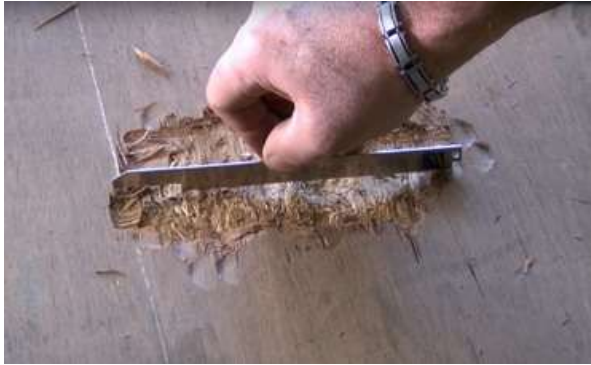
Photo 11

Flooring

Fail

Patch this up, make sure no nails are protruding

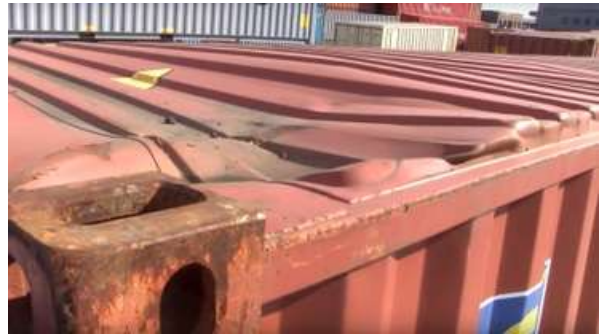
Photo 12

Roof panel

Fail

This is the root cause for roof hole near the front wall. Repair this as well.
