# 22 Apr 2019 / 3B7KF23642M238968 / Jaunter X5

Pre-delivery Inspection Checklist Conducted on 22nd Apr, 2019 By SafetyCulture Staff

Inspection score	Failed items	Created actions
95.73%	5	3
Site		
Sydney		
Car Make/Model		
Jaunter X5		
Vehicle Identification Number		
3B7KF23642M238968		
Dealer		
Shining Motors, Inc.		
Location		
722 Charles St., Detroit, MI 48226		
Inspected by		
Charista Perez		
Conducted on		
☐ 22nd Apr, 2019 ③ 11:44 AM +	+08

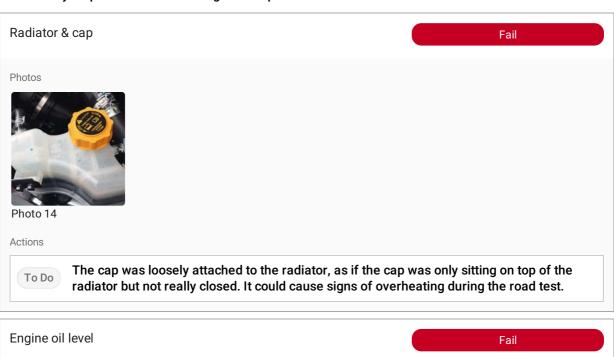
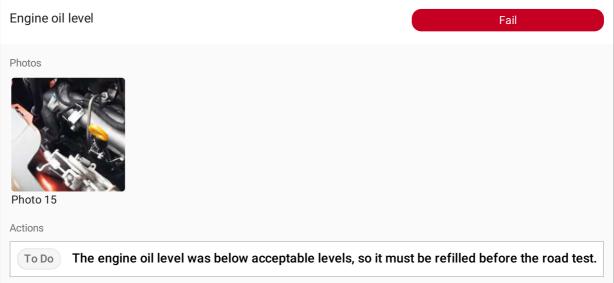
#### Pre-delivery Inspection Checklist / Engine Compartment

SafetyCulture Staff created a High priority action
To Do
Refill engine oil
The engine oil level was below acceptable levels, so it must be refilled before the road test.
Pre-delivery Inspection Checklist / Engine Compartment
Pre-delivery inspection checklist / Engine compartment
Engine oil level
SafetyCulture Staff created a High priority action
To Do 22nd Apr, 2019 8:00 AM +08
Replace radiator cap
The cap was loosely attached to the radiator, as if the cap was only sitting on top of the radiator but not really closed. It
could cause signs of overheating during the road test.
Pre-delivery Inspection Checklist / Engine Compartment
Radiator & cap
SafetyCulture Staff created a High priority action
To Do
23/d Aβ1, 2019 0.00 AW1 100
Locate spare tire
The spare tire wasn't in the rear compartment when I checked.
Pre-delivery Inspection Checklist / Wheels & Tires
Spare tire

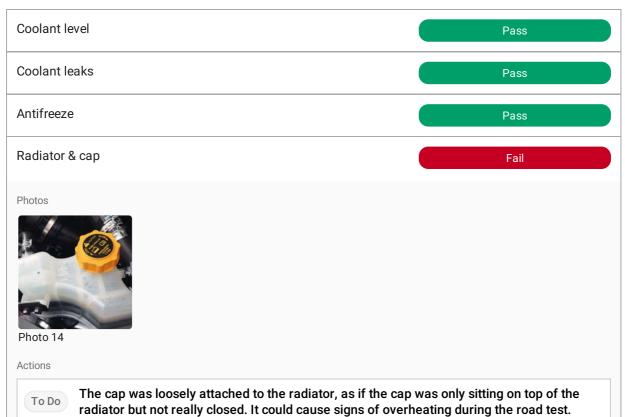
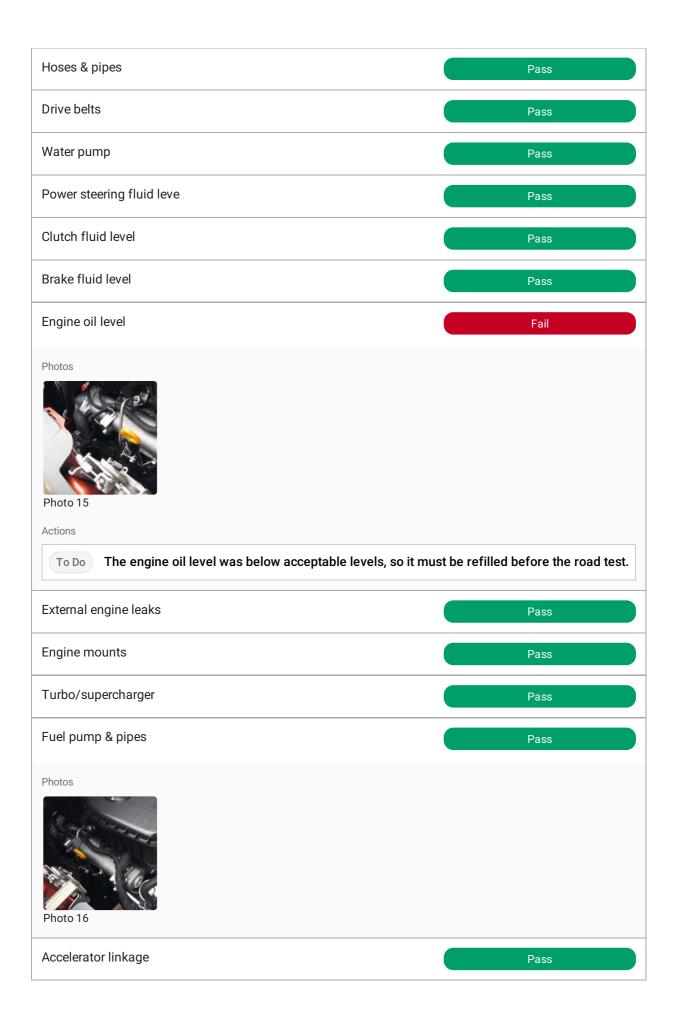
### **Engine Compartment**

2 Failed 2 Actions
