Visual Inspection Report Form Conducted on 3rd May, 2019 By SafetyCulture Staff

Site Sydney
Company Steelix Manufacturing Ltd.
Department Welding
Address 3428 Hillcrest Lane, Primmer CA
Prepared by Samantha Leibnitz
Conducted on 📅 3rd May, 2019 ⌚ 2:04 PM +08

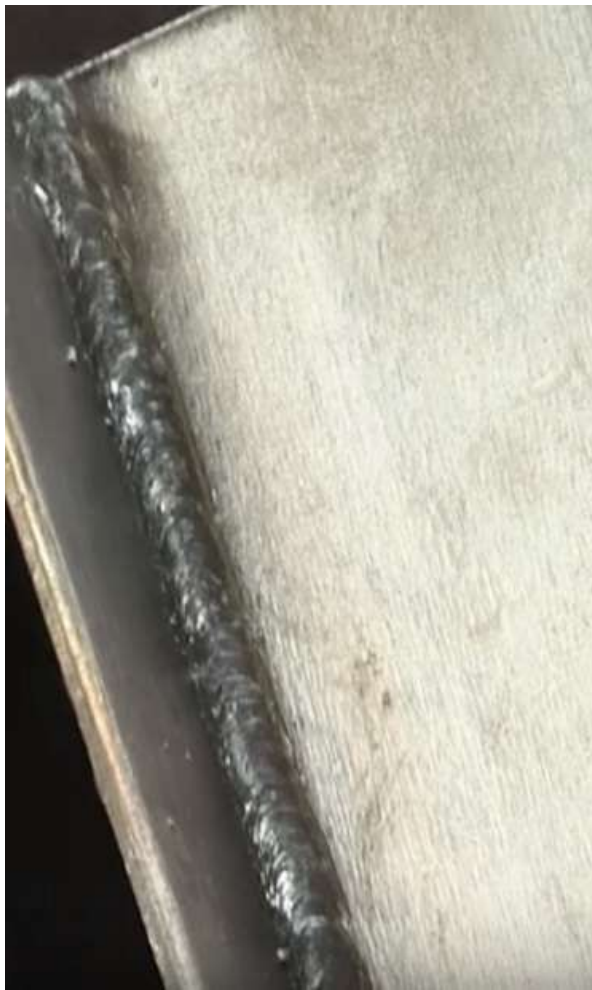
ID & Location 01 / AE03	
Take/attach photos	
Photos

Photo 1	
Defect Criteria	Pass

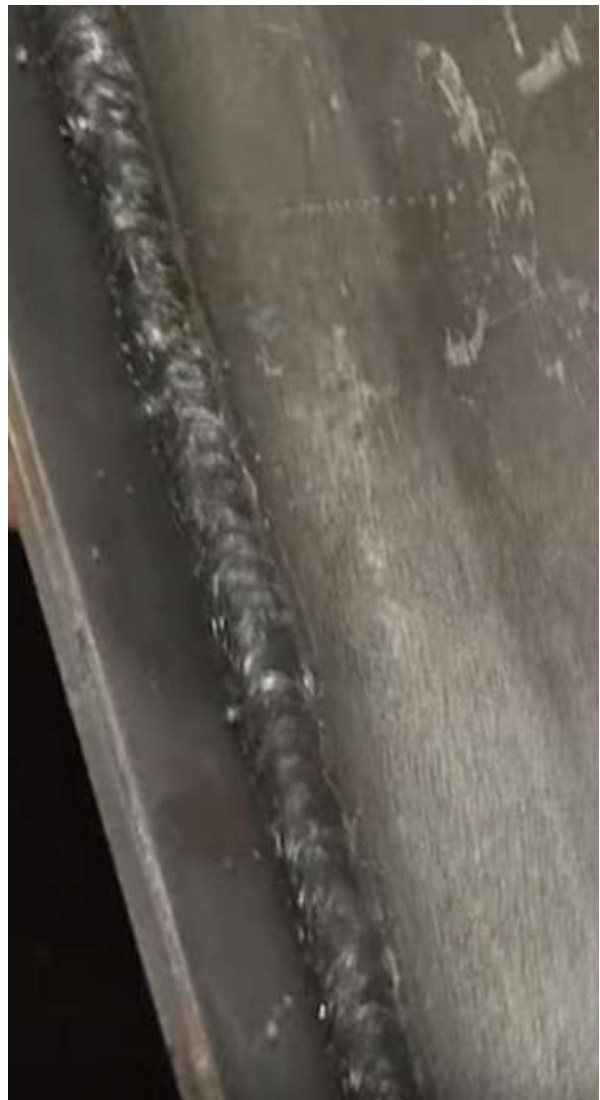
ID & Location 02 / AE03	
Take/attach photos	
Photos

Photo 2	
Defect Criteria	Pass

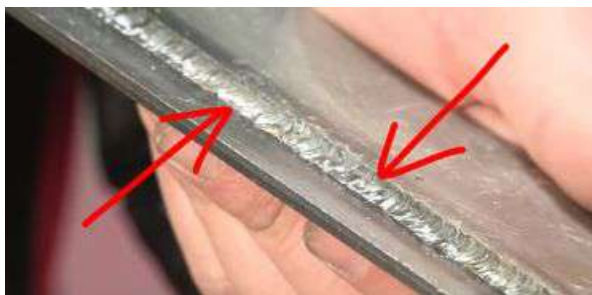
ID & Location 03 / AE03	
Take/attach photos	
Photos

Photo 3	
Defect Criteria	Fail
Identify visual defect/s.	
Incomplete fusion Arc strikes

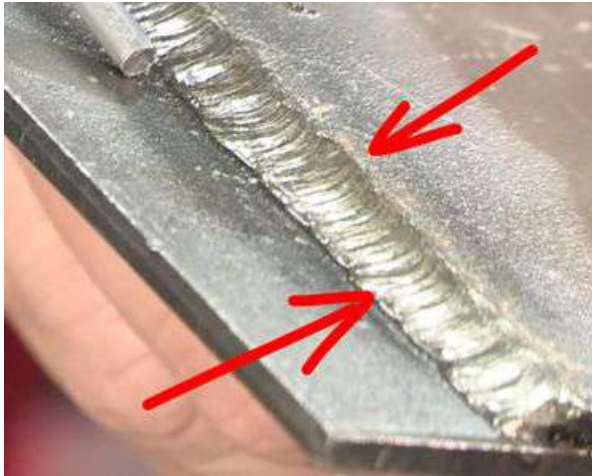
ID & Location 05 / AE03	
Take/attach photos	
Photos

Photo 5	
Defect Criteria	Fail
Identify visual defect/s.	
Burn through Under cut

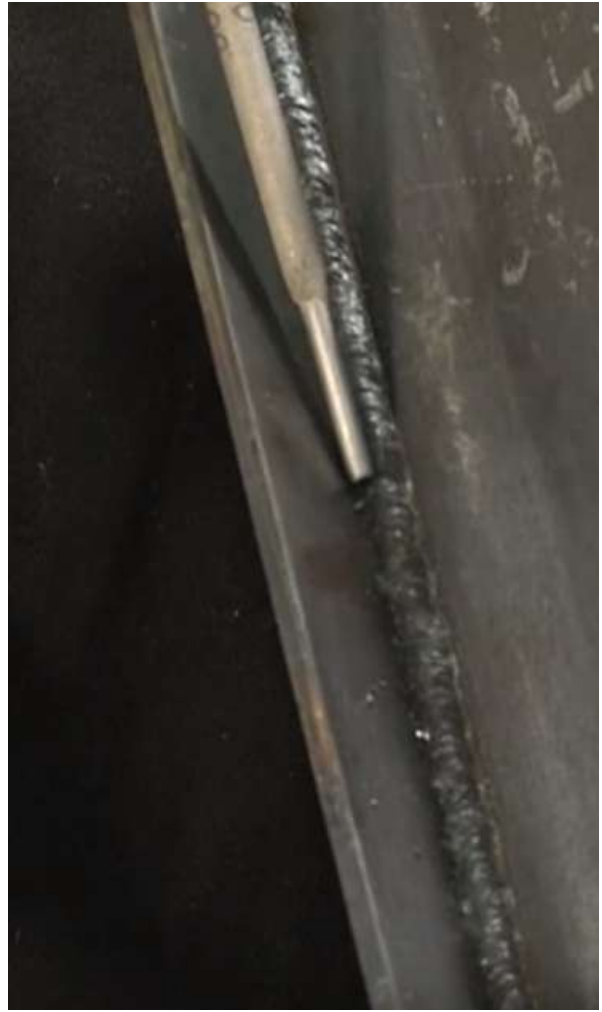
ID & Location 04 / AE03	
Take/attach photos	
Photos

Photo 4	
Defect Criteria	Pass

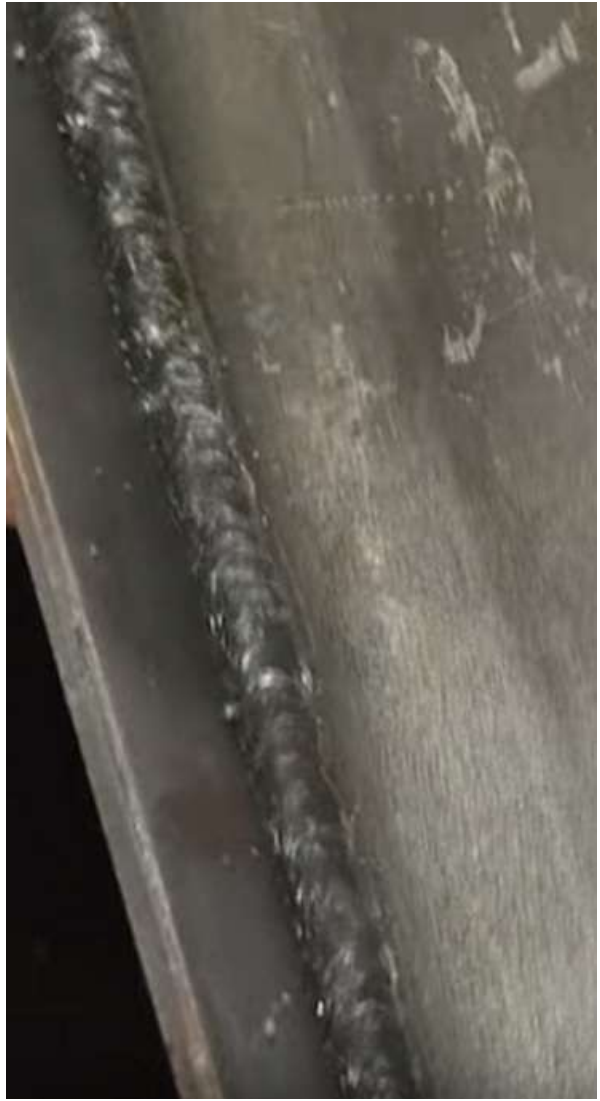
ID & Location 06 / AE03	
Take/attach photos	
Photos

Photo 6	
Defect Criteria	Pass
