Home Inspection Checklist

Inspection score	Failed items	Created actions
<b>96.12%</b>	<b>4</b>	<b>0</b>
Property Address 4003 Paloma Cir, Austin, TX 78734, USA		
Conducted on 📅 26th Oct, 2018 ⌚ 7:01 AM +08		
Prepared by Adam Alexander		
Prepared for Dianna Stevens

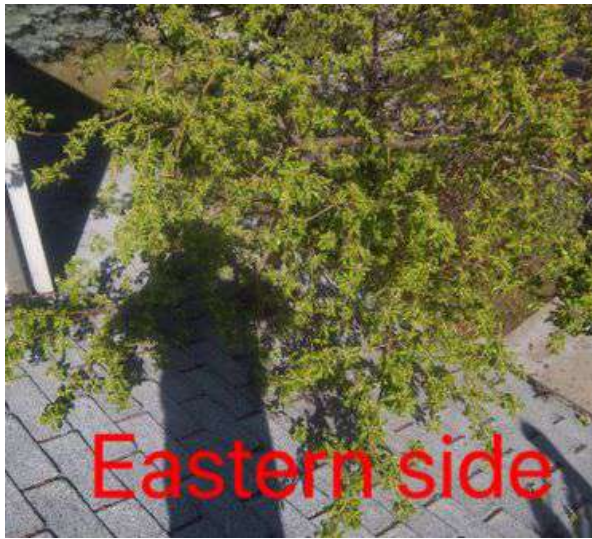
Photo 1

No branches or bushes touching the house or overhanging the roof

Tree on the eastern side of the house is overhanging the roof.

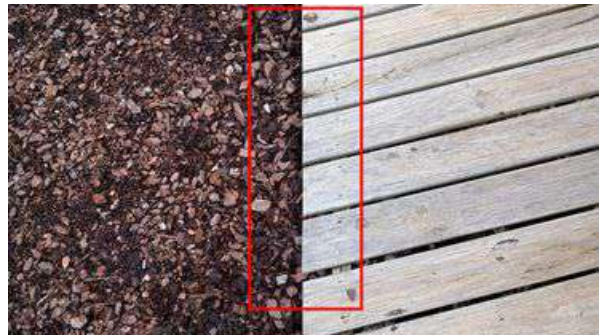
Photo 2

Adequate clearance between ground and wood siding materials; no wood-to-earth contact

Clearance not adequate. No wood to earth direct contact but almost touching.

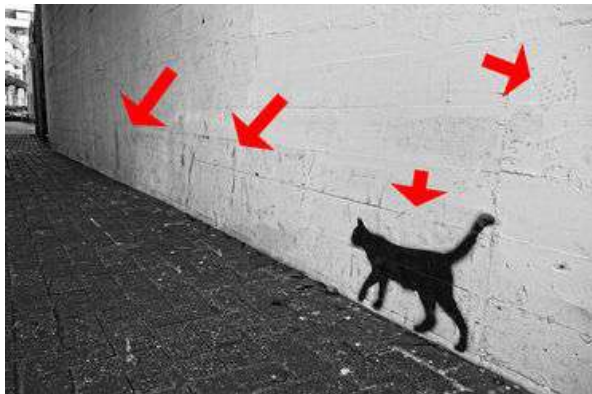
Photo 3

No stains on exterior surfaces

At the back of the house is this painting of a cat and the noticeable shoe print apart from the stains on the white wall.

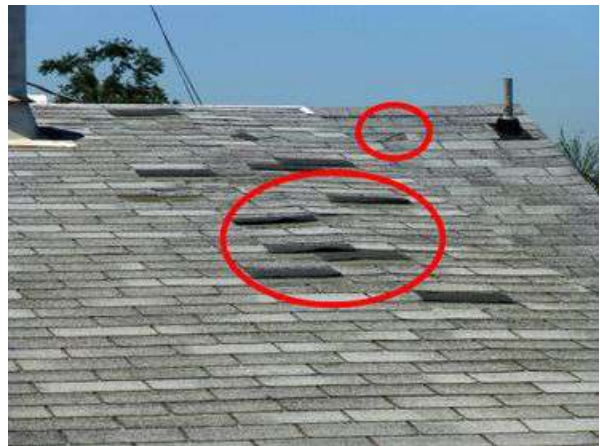
Photo 4

Composition tiles / shingles: no curling, no cupping, no loss of granulation particulate, no broken, damaged or missing shingles, no more than two layers of roofing

South side roof show signs of curling and damage.
