Termite Inspection Checklist

Inspection score	Failed items	Created actions
79.31%	4	1
Property/Site/Client North House		
Conducted on 📅 10th Jan, 2020 ⌚ 3:05 PM +08		
Prepared by Paul Smith		
Location E Suncrest Rd Anaheim Hill and Canyon Area CA 92807 United States (33.84955327609349, -117.7961596071193)

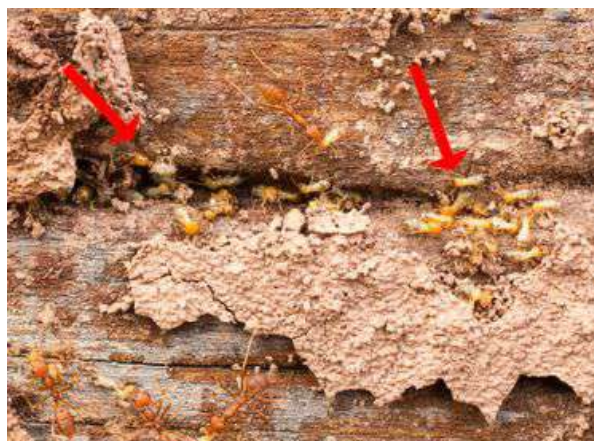
Photo 1

Foundation of the property, garage, and other points with exposed wood that connect with the soil	No
<p>– Notes</p> <p>Foundation on the south-west of the property</p> <p>– Photos</p>

Foundation on the south-west of the property has signs of a new termite nest. That same area had a termite infestation around 3 years ago. Urgently need to contact the pest control to treat and make sure the rest of the property do not have other pests.

Our North House's south-west foundation, the one where we had the same termite infestation 3 years ago, has termites again. Please contact the same pest control guys we had then.

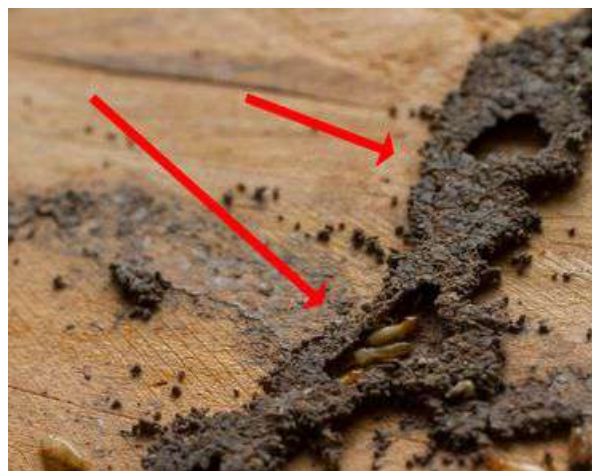
Photo 2

Points where soil comes into direct contact with wood, particularly untreated wood	No
Areas where surface water, or wet soil, contacts or is very near the structure	Yes
Areas where foundation material has degenerated and become permeable, cracks in slab, and expansion joints in slab	Yes
External foundation walls (Look for mud tubes)	No
<p>– Photos</p>

Moist mud tubes and broken mud tubes that get repaired later indicate an active termite tunnel.
