Plumbing Inspection Checklist

Inspection score	Failed items	Created actions
80%	3	1
Site Camel Homes Residence		
Plumbing Approval Number: SS-123489		
Date and Time of Inspection 📅 6th Jan, 2020 ⌚ 8:00 AM +08		
Prepared by (Full Name) Keys Roms		
Location 904 Gonzalo Puyat St, Quiapo, Manila, 1001 Metro Manila, Philippines

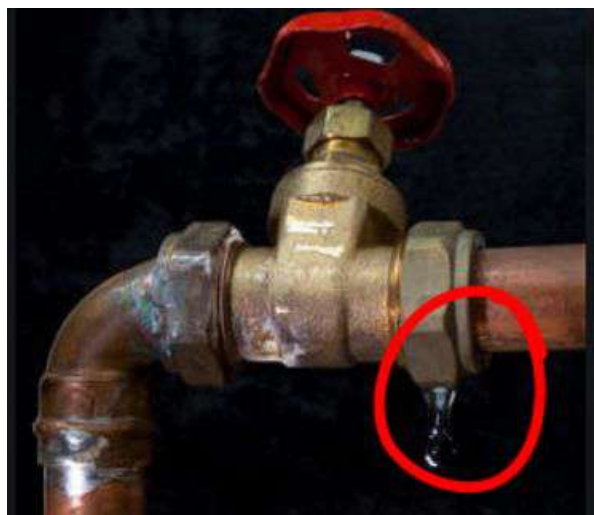
Photo 1

Are all valves free from leaks?	No
<p>– Notes</p> <p>Main water valve has visible water drips when turned off</p> <p>– Photos</p>

There is a leak at the main water supply

- Leak found at the main water supply. It needs to be repaired immediately.
- Clean the gutter near the kitchen area this is the possible reason of the visible leak stains

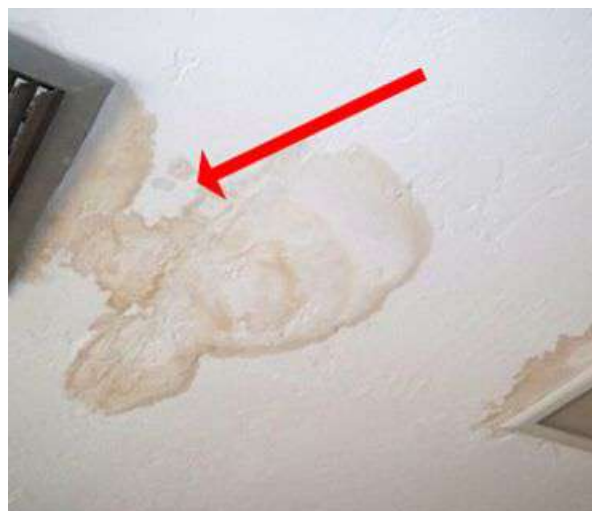
Photo 2

No visible signs of water stains on walls and ceilings?	No
<p>– Notes</p> <p>There is a visible water stain near the vent system at the kitchen area</p> <p>– Photos</p>

Are faucets free from leaks and damages?	Yes
No water drips when the spigot is turned off or when the water is running?	Yes
No visible signs of water stains on walls and ceilings?	No
<p>– Notes</p> <p>There is a visible water stain near the vent system at the kitchen area</p> <p>– Photos</p>

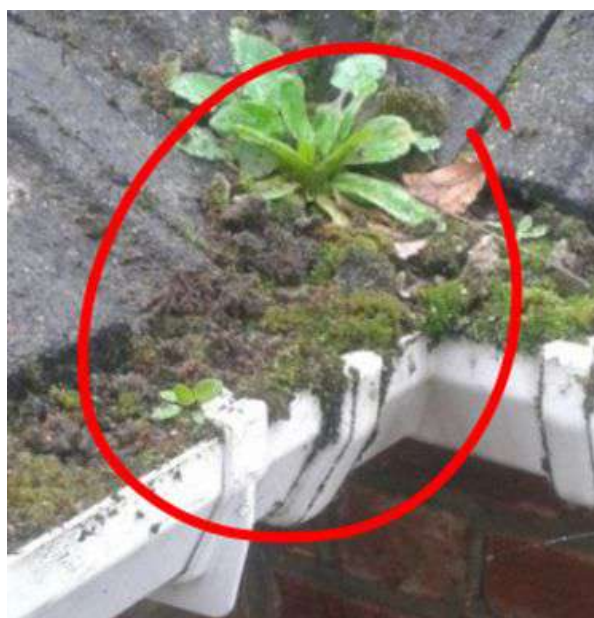
Photo 3

Is the gutter unobstructed?	No
<p>– Notes</p> <p>Debris found at the gutter</p> <p>– Photos</p>

Is the water pressure at a safe level?	Yes
No visible signs of cracks, brittleness, or leaking?	Yes
Is the drainage line free from corrosion and pipe damage?	Yes
Is the gutter unobstructed?	No
<p>– Notes</p> <p>Debris found at the gutter</p> <p>– Photos</p>
