3J's Construction Company / 28 Feb 2020 / Gill Terone

CDM Checklist (Designers)

Production Company 3J's Construction Company
Programme Title ABC Project
Conducted on (Date and Time) <input type="checkbox"/> 28th Feb, 2020 <input type="checkbox"/> 8:07 AM +08
Designer Gill Terone
Location 39-41 high streets peterport, Moffat GY1 2JT, UK

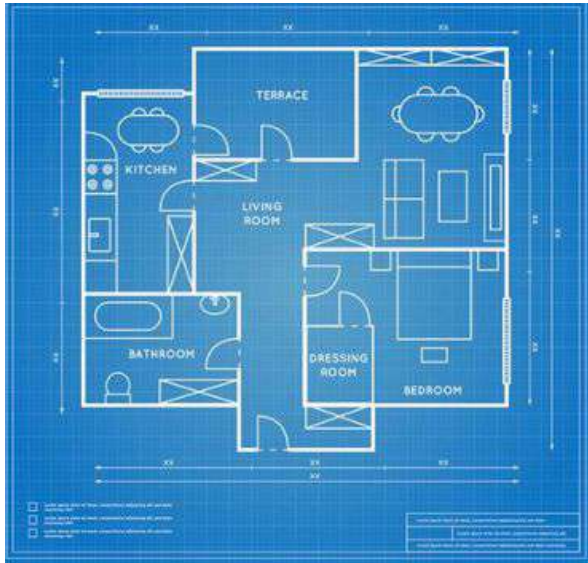
Photo 1

Take a photo of design drawings
