# Routine Inspection of Stalwart Bridge

Inspection score	Failed items	Created actions
<b>75.44%</b>	<b>0</b>	<b>1</b>
Audit Title Routine Inspection of Stalwart Bridge		
Document No. 005628		
Client / Site Amaranth Corp Redux		
Conducted on Unanswered		
Prepared by Jonathan Conner		
Location Manhattan, New York		
Personnel Jason Lamb - Program Manager Stanley Bruce - Team Leader Jenny Mara - Load Rater

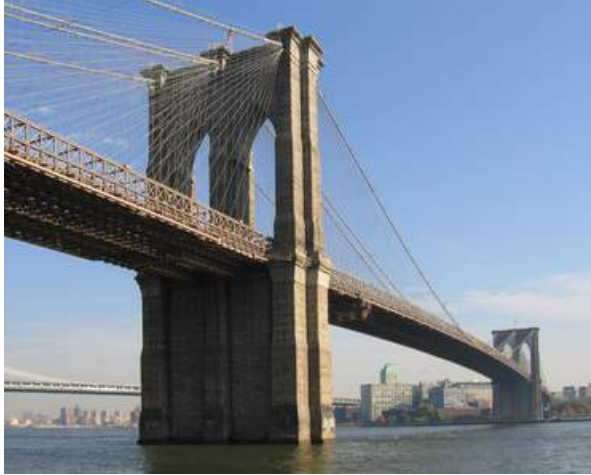
Bridge # <b>008-4/5-2.95(01214)</b>
📅 5th Feb, 2020 🕒 6:20 PM +08
Photo 1 - Upstream Face
– Photos

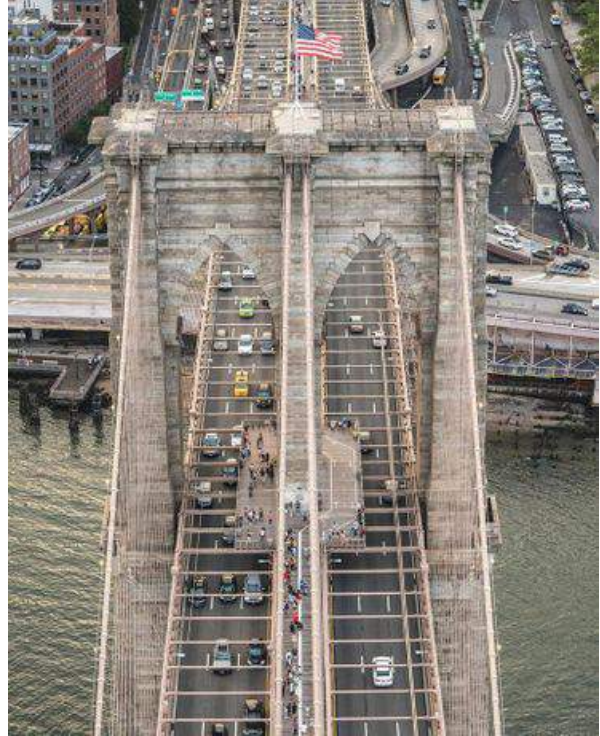
Photo 1
Photo 2 - Downstream Face
– Photos

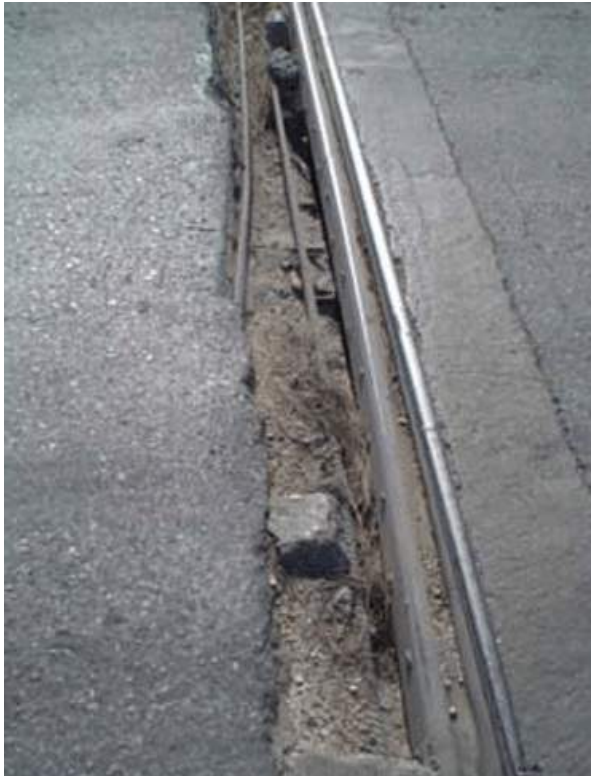
Photo 3

Joint Condition	Poor
<p>– Photos</p>

<p>Photo 3</p> <p>– Actions</p> <p><b>ToDo</b> Check and apply silicone seal for reinforcement.</p>	
Drain Condition	Fair
Rail Condition	Fair
<p>– Notes</p> <p>Nothing notable aside from natural wear and scratches.</p>	
Sidewalk Condition	Fair
Live Load Deflection/Vibration	Moderate
Debris Accumulation on Deck	Light
Overall Deck Condition	Fair
NBI Deck Cond. 9-Excellent; 8-No Problems Noted, 7-Mnr Problems; 6-Mnr Deterioration; 5-Mnr Cracking; 4-Adv Deterioration; 3-Loss of Section; 2-Monitor Closely/Close Til Repair; 1-Br Closed til Repair; 0-Beyond Repair	7 From 1 to 10

Deck General Comments <b>Aside from minor joint repair work, everything else is in good condition.</b>
Additional Photo If Necessary Unanswered
Additional Photo If Necessary Unanswered
Additional Photo If Necessary Unanswered
Additional Photo If Necessary Unanswered

**Check and apply silicone seal for reinforcement.**

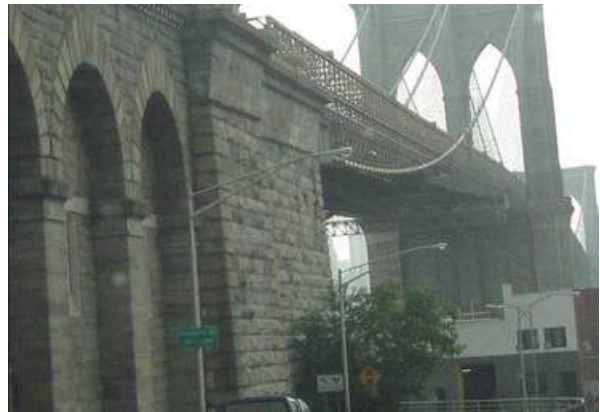
Photo 4

Bearings	Fair
Cap	Fair
Piling Foundations	Fair
Pile Type	Prestressed Concrete 14"
Back Wall	Fair
- Notes No noticeable damage.	
- Photos
