# Fix and Waterproofing Inspection Checklist

30 Jul 2020 / Philip Dunphy / Fixing Stage /  
Matthew Davis

Score	50%	Failed items	3	Actions	3
<b>Client Name</b>					Philip Dunphy
<b>Subject Property</b>					14 Pine St, Marrickville NSW 2204, Australia (-33.9086828, 151.1456221)
<b>Builder</b>					Maslow Corp
<b>Inspection Date &amp; Time</b>					30th Jul, 2020 2:00 PM +08
<b>Inspected By</b>					Matthew Davis
<b>Stage of Work</b>					Fixing Stage
<b>Inspection Notes</b>	At the time of this inspection, we note the following;				
	1. The balcony waterproofing had not been done.				
	2. The garage ceiling had not been plastered.

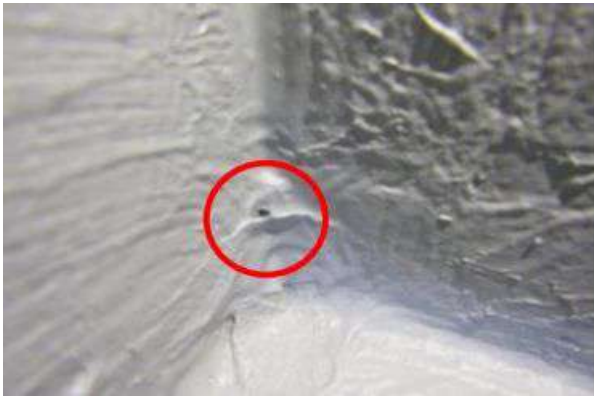
Photo 1

Wet areas

Waterproofing Holes

These are numerous holes in the waterproofing membranes applied to the wet areas of this home, which will likely lead to water leaks and damage in the future.

This waterproofing has been poorly applied with no care taken whatsoever, all of these areas will need to be rectified and properly waterproofed so the wet areas are actually waterproof

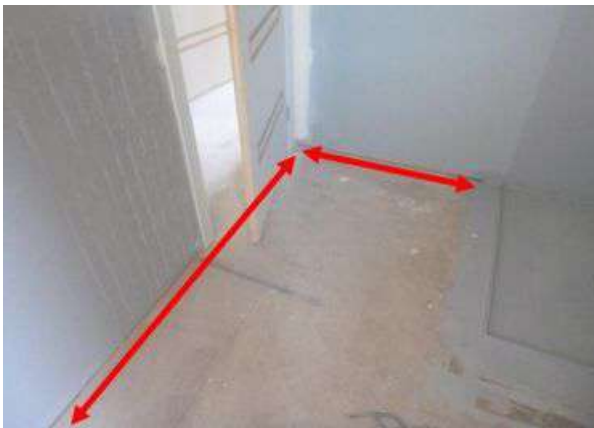
Photo 5

Waterproofing Extent

None of the wall/floor junctions or door openings throughout the wet area rooms of this home have been properly waterproofed as required by the BCA and the relevant Australian Standard - AS 3740, which will allow water to leak into the frame and cause possible future damage.

Notify the builder in charge to install waterproof wall/floor junctions to all of the wet areas of this home as required by the NCC/BCA and the relevant Australian Standard - AS 3740

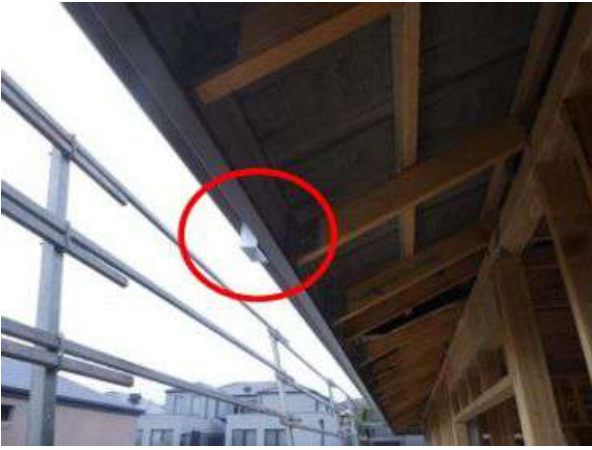
Photo 7

Site drainage

The downpipes have not been connected (temporary or otherwise) to the stormwater system throughout most of this build, which has directed water onto the ground adjacent to the footings and may be contributing to future slab heave issues. There have not been temporary downpipes fitted to the gutters of this house, which is directing water collected from the roof onto the ground immediately adjacent to the footings.

Notify builder to immediately place temporary downpipes fitted to the gutters, and the site drainage rectified to prevent further ponding of water against the footings
