Roof Inspection Checklist

Mr. Seonil Jung / Potts Point / 21 Sep 2020 / Riley
Bautista

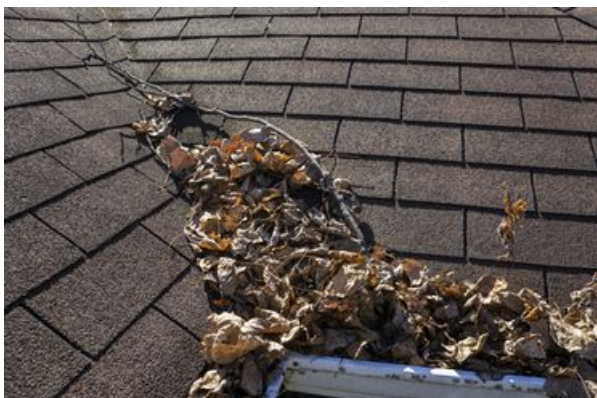
Photo 1

Leaves were found on one corner of the roof

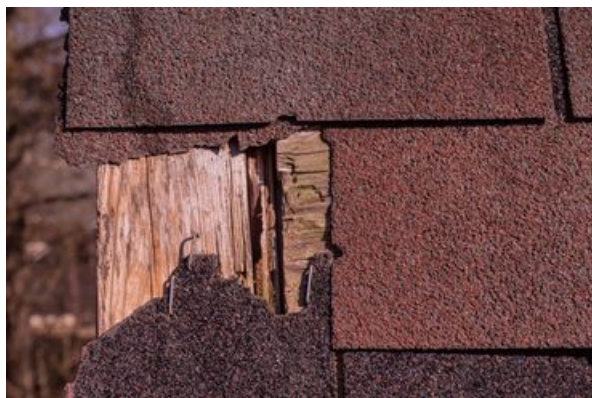
Photo 2

A cracked shingle was discovered at the left side of the house. It was probably caused by the recent storm in the area

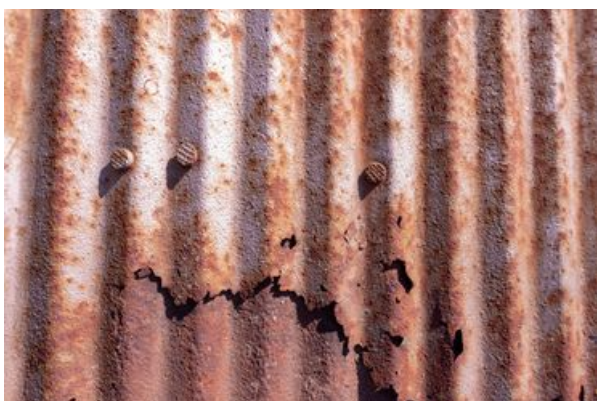
Photo 3

The roof of the dog's house at the backyard was found to be rusty

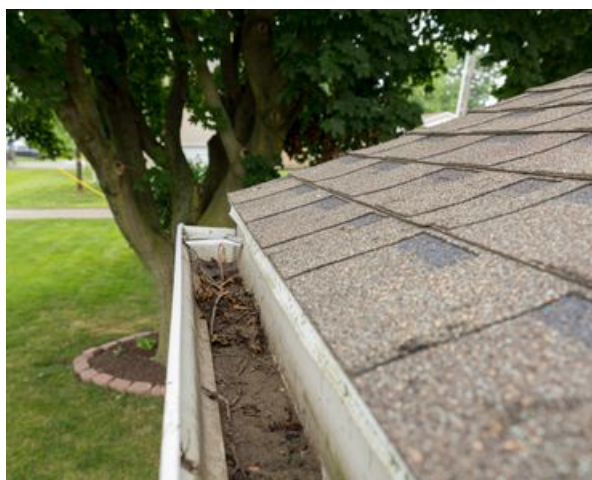
Photo 4

Gutter is clogged with tree leaves and sticks

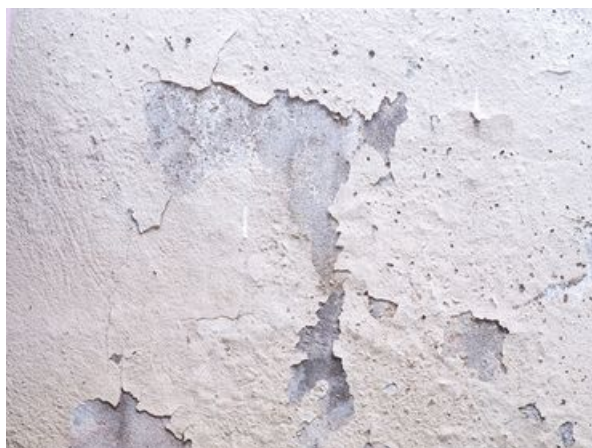
Photo 6

Deformed Finish

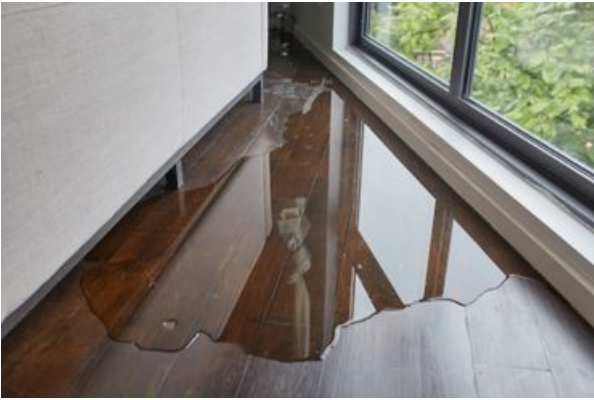
Photo 7

Window Leaks

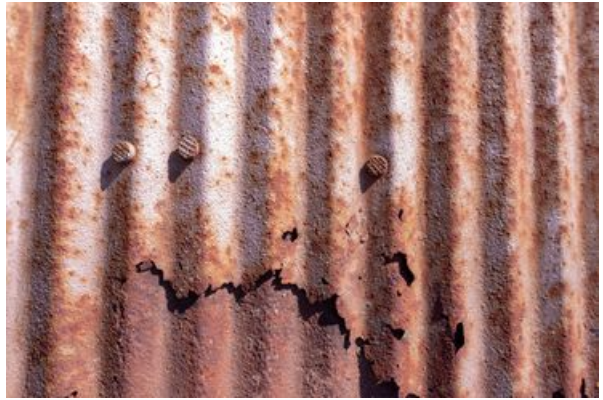
Photo 8

Take a photo of degradation in roof system
