Construction Risk Assessment Form

17 Sep 2020 / 372-2345 / Jeremiah Ronson

Score	77.27%	Failed items	1	Actions	1
Job #	372-2345				
Conducted on	17th Sep, 2020 11:00 AM +08				
Prepared by	Jeremiah Ronson				
Location	3516 Lakeland Park Drive, Milwaukee WI				
Proposed work description	Construction of 2-story building as new retailer complex.

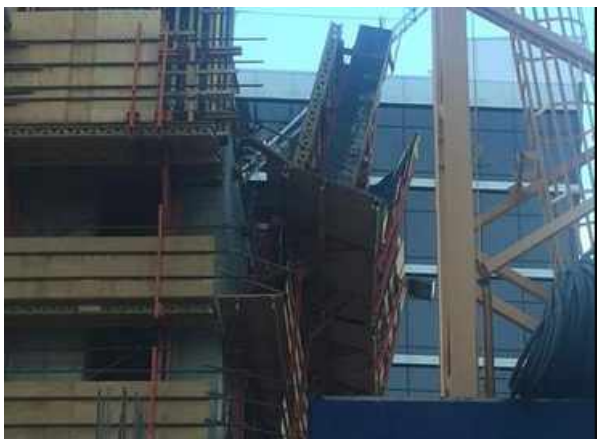
Photo 1

Loose scaffolding on the west side of the building. Foreman was immediately informed. This problem should be fixed before the end of the day. Prohibit workers from working on or underneath loose scaffolding.

Injury and/or fatality by being struck by objects or through possible falls are imminent unless scaffolding issues are fixed ASAP. Action already created.

Fatality/ Disability

High

Standards, materials, and practices concerning scaffolding, working at heights, and falling objects must be reviewed. Loose scaffolding was detected in the west side of the building which had the potential to cause major injuries and fatalities.

All workers and personnel were cleared from the immediate vicinity of the loose scaffolding. A "restricted area" was established with barriers and tapes to ensure that no one would be in danger of falling objects from the loose scaffolding detected.
