Legionella Risk Assessment

GlassCloud / 5 Oct 2018 / Orin Mutchler

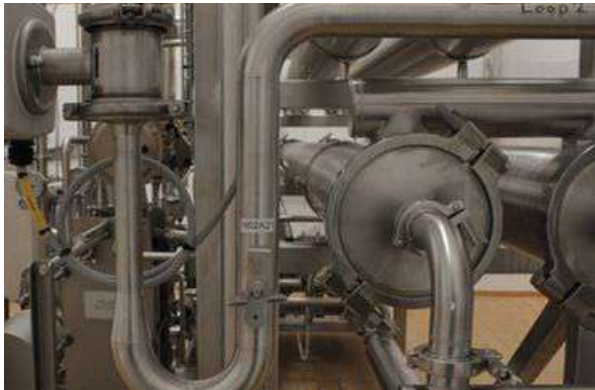
Photo 1

Cold water system pipe and faucet

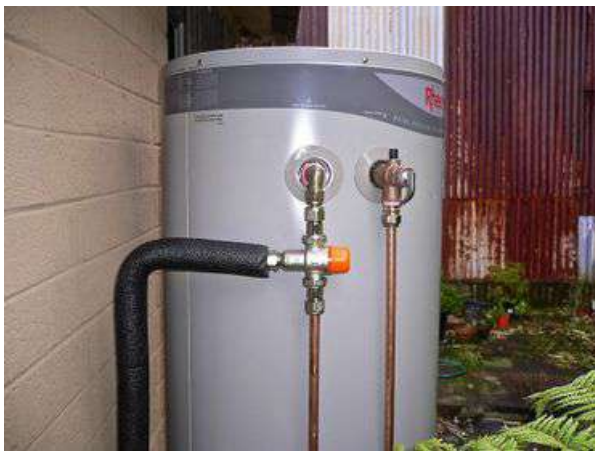
Photo 3

Rheem 111 250 litre electric hot water system installed with a tempering valve

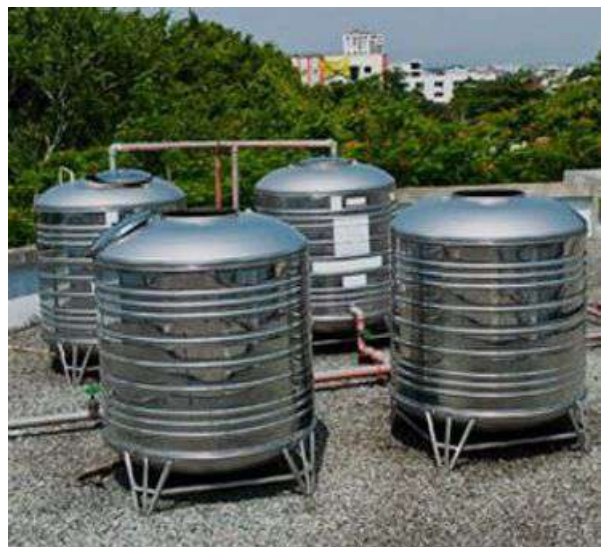
Photo 4

Cold water storage tank location (photo)

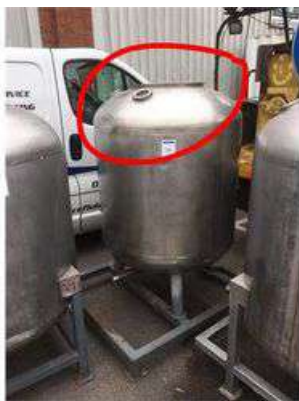
Photo 5

Does it have a tight-fitting lid?

No

Is a cold water storage tank present?	Yes
Is the cold water tank accessible?	Yes
Does it have a tight-fitting lid?	No

Please make sure to put tank lid

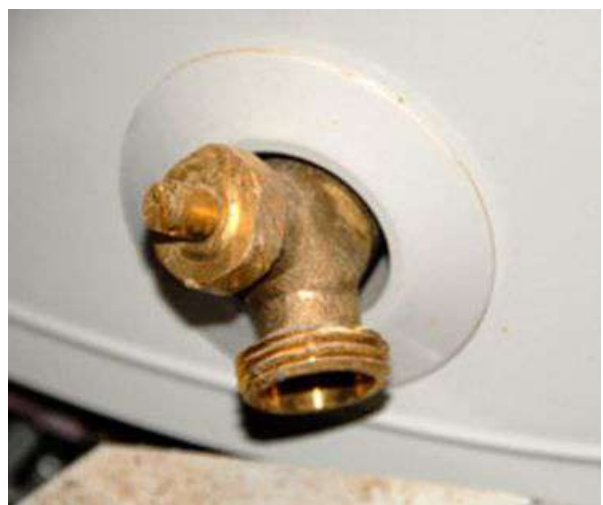
Photo 6

A drain valve?	Yes
----------------	-----

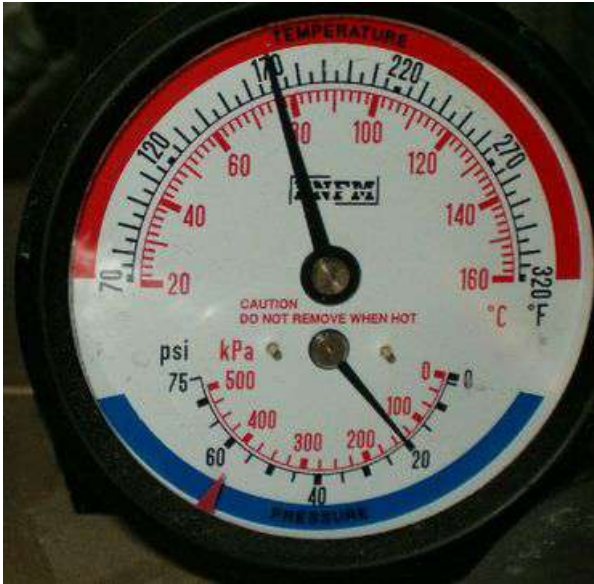
Photo 7

A temperature gauge on the inlet and outlet?	Yes
--	-----

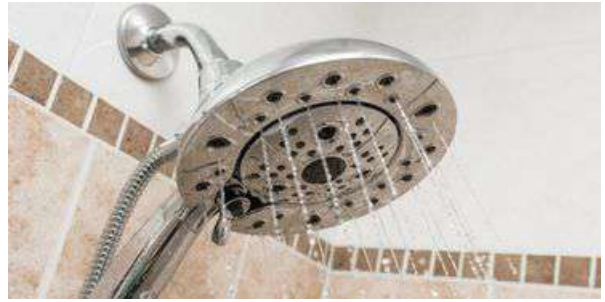
Photo 8

Take photo of shower location
