# Termite Inspection Checklist

Score	79.31%	Failed items	4	Actions	1
<b>Property/Site/Client</b>					
North House					
<hr/>					
<b>Conducted on</b>				10 Jan 2020 15:05 PST	
<hr/>					
<b>Prepared by</b>				Paul Smith	
<hr/>					
<b>Location</b>				E Suncrest Rd Anaheim Hill and Canyon Area CA 92807 United States (33.84955327609349, - 117.7961596071193)	
<hr/>

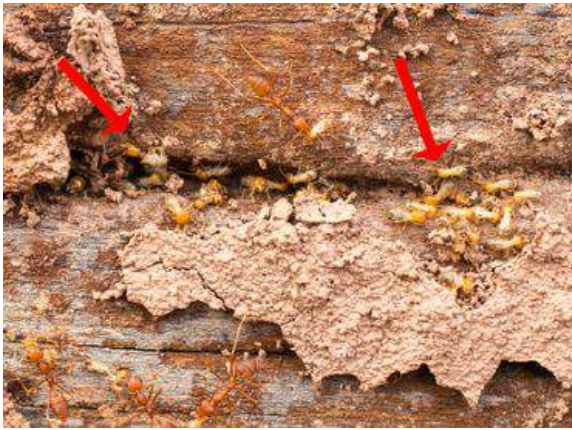
Photo 1

Foundation of the property, garage, and other points with exposed wood that connect with the soil

No

Foundation on the south-west of the property

Foundation on the south-west of the property has signs of a new termite nest. That same area had a termite infestation around 3 years ago. Urgently need to contact the pest control to treat and make sure the rest of the property do not have other pests.

Our North House's south-west foundation, the one where we had the same termite infestation 3 years ago, has termites again. Please contact the same pest control guys we had then.

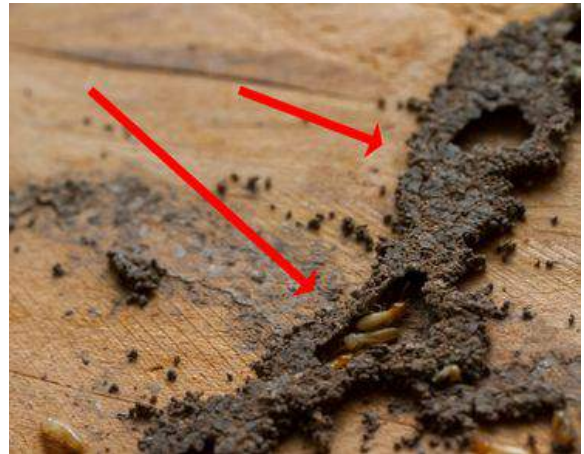
Photo 2

External foundation walls  
(Look for mud tubes)

No
