FHA Appraisal Checklist - Health & Safety

The One Bank

Marion, IA 52302

26 Oct 2018 05:57 PM

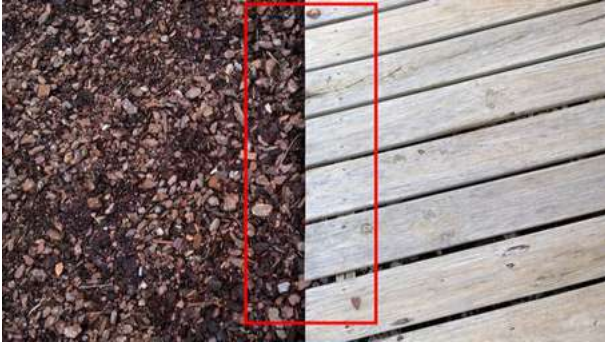
Appendix 5

Question	Response	Details
Operating oil or gas wells with 75 feet of new construction	Yes	Main house gas pipeline is facing a Main Street gas pipe
Structure and accessory buildings are ground level and/or wood is touching ground	Yes	garden area touching the ground

Property lacks connection to public/community sewer system (Note the sewage connection – Public/community or septic)	No	
<p>Determine whether connection to a public system is feasible. If connection is feasible, hookup is MANDATORY. Report to the Lender where the sewer line is located, distance from house and feasibility.</p> <p>NOTE: If house is vacant - require septic tank service and inspection.</p>		
Wood Destroying Insects		Score (1/2) 50.00%
Structure and accessory buildings are ground level and/or wood is touching ground	Yes	garden area touching the ground

Question	Response	Details
No hot water	Yes	Water didnt get hot
Please identify location of all health and/or safety deficiencies, and note others not included in this or any other VC on the comment page.	Yes	Roof needs repair Water heating is not working Wall at garden area touching the ground Crawl space is not enough for repair

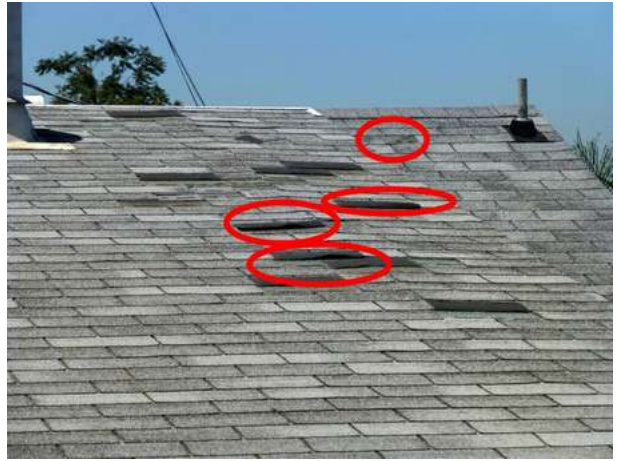
Appendix 6

<p data-bbox="140 810 256 837">Appendix 5</p>		
Space inadequate for maintenance and repair	Yes	Crawl space doesnt have enough space for maintenance.
Evidence of deterioration of roofing materials (Look for evidence of shingles curling up and breaking off). NOTE: An excellent tool for inspecting the roof is a pair of binoculars when observing the roof from the ground.	Yes	Roof deterioration at south side

Roofing		Score (5/6) 83.33%
Does not cover entire house (Note if the roof covers the entire home, if the roof has been repaired, or patched substantially, if material used on the roof was suitable for the subject property)	No	
Evidence of deterioration of roofing materials (Look for evidence of shingles curling up and breaking off). NOTE: An excellent tool for inspecting the roof is a pair of binoculars when observing the roof from the ground.	Yes	Roof deterioration at south side
