Facility Condition Assessment Template

Zetastar Building One

18 Feb 2019 10:48 AM

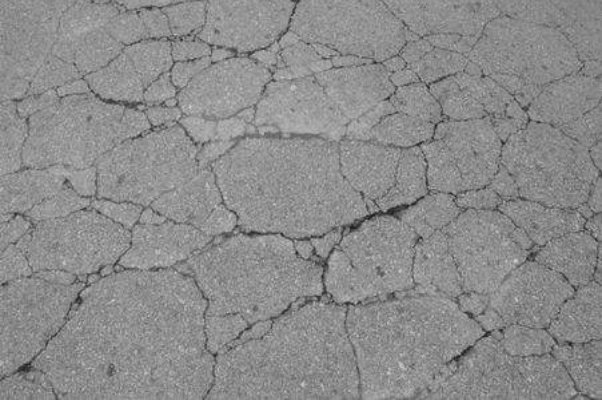
Appendix 1

Question	Response	Details
<p>Item status guide: 5 Excellent - Brand new and no issues to report - Plan for 8 to 10 year span 4 Good - No immediate issues or concerns - Consider replacement in 6 to 8 years 3 Fair - Average wear for building age. Not new but no immediate issues. - Replace within 5 to 6 years 2 Poor - Worn from use. Nearing end of expected life cycle. - Replace within 2 to 4 years 1 Critical - Extremely worn or damaged - Replace within the next 2 years</p>		
Sitework		
Roads	2 - Poor	Cracked asphalt starting from main parking entrance.

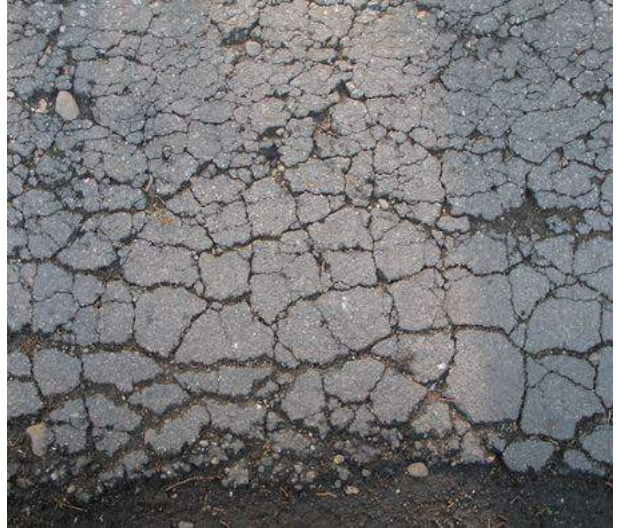
Appendix 2

<p style="text-align: center;">Appendix 1</p>		
Parking	2 - Poor	Further road damage from the main entrance leading to the parking area.

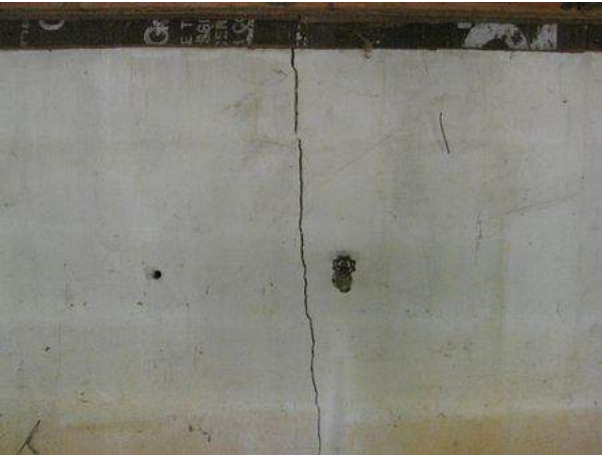
Appendix 3

Question	Response	Details
Landscaping	5 - Excellent	
Building Structure		
Foundations	3 - Fair	Minor settlement cracks were observed in various locations in the foundation walls. This implies that some structural movement of the building has occurred. Cracks of this type should be watched for any sign of additional movement. In the absence of any sign of ongoing movement, repair should not be necessary.

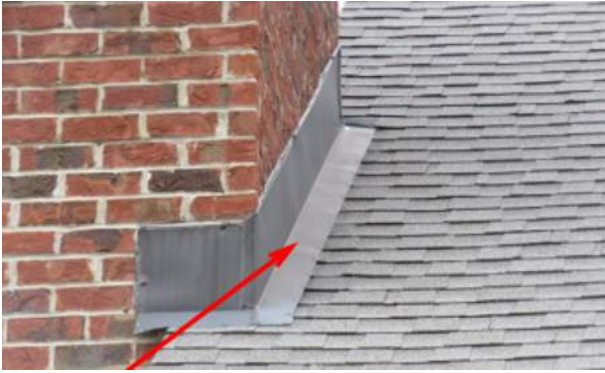
Appendix 5

Question	Response	Details
Floor finishes	4 - Good	
Walls	3 - Fair	Minor hairline cracks in interior walls. No immediate repairs needed.

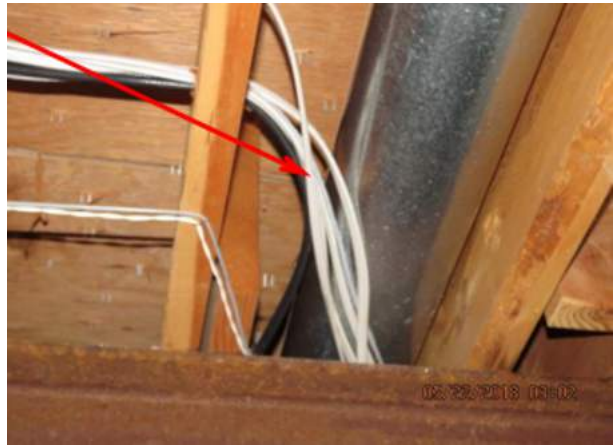
Appendix 6

<p>Appendix 4</p>		
Wall finishes	3 - Fair	No problems aside from minor, normal hairline cracks.
Ceilings	4 - Good	
Casework (cabinets, bookcases, nightstands)	4 - Good	
Fixtures	4 - Good	
Doors	4 - Good	
Hardware (bolts, nails, screws, hinges, locks, bolts, latches)	4 - Good	
Building Exterior		
Roofing structures	3 - Fair	The installation of the chimney flashing is incomplete and should be repaired to avoid leaks. Aluminum should not be used on chimney flashing because aluminum reacts with the lime in the mortar. The flashing should be galvanized steel embedded in the chimney and installed counter flashing to the roof line over step flashing. Have this evaluated by a tinsmith.

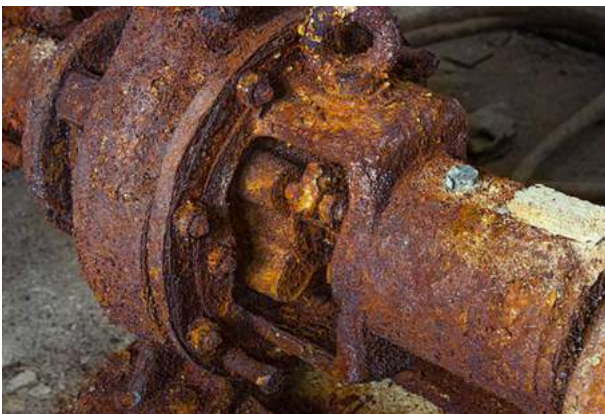
Appendix 7

Question	Response	Details
Breezeways	4 - Good	
Stairs	4 - Good	
Exterior walls	4 - Good	
Exterior windows.	4 - Good	
Mechanical Systems		
Heating, ventilation and air conditioning (HVAC) systems	4 - Good	
Electrical Systems		
Electrical wiring	3 - Fair	Wiring in the basement should not touch hot air ductwork or hot water piping.
  <p>Appendix 6</p>		
Sockets	4 - Good	
Lighting	4 - Good	
Emergency generators.	4 - Good	
Plumbing		
Piping	2 - Poor	Corrosion on the exterior of the supply piping was observed.
  <p>Appendix 7</p>		
Water pressure	4 - Good

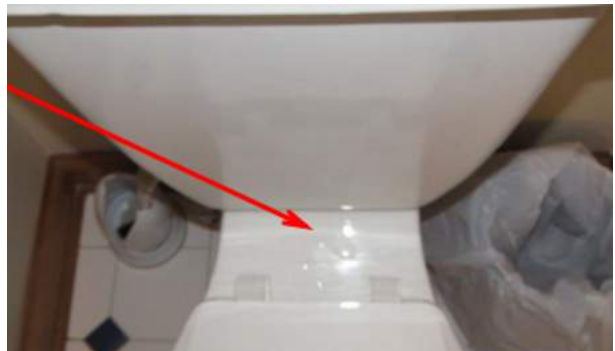
Appendix 8

Question		Response	Details
Toilets		2 - Poor	The toilet tank is loose in the second floor bathroom. Recommend securing to the bowl and replace gasket as needed.
