Site Investigation Report Template

West coast project

2370 Humboldt Rd, Chico, CA 95928, USA

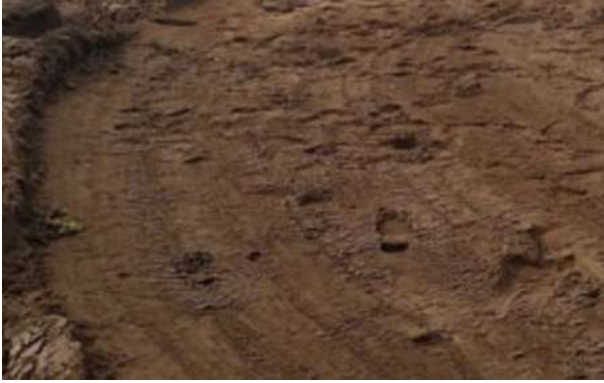
Appendix 1		
Structure		
Grade	Strong

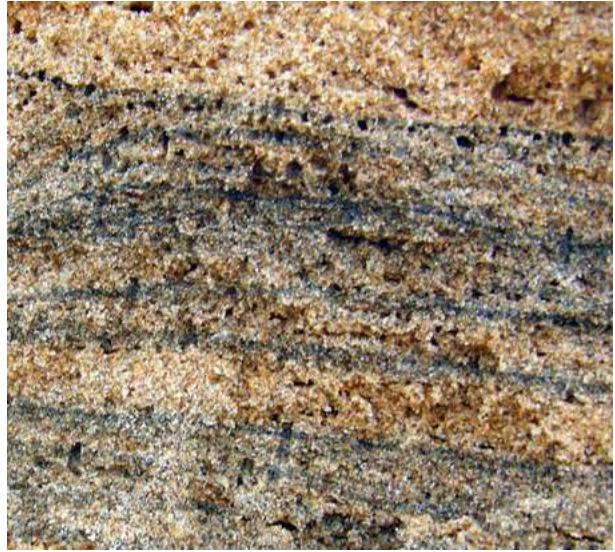
Appendix 2

Question	Response	Details
Size	Coarse	
Shape	Granular	
Rock Fragments		
Rock Fragments	Irregular	
Type of Rock	Sandstone	
  <p>Appendix 2</p>		
Terms of Rock	Stratified	
Mottles		
Quantity	Common	
Size	Medium	
Contrast	Distinct	
Boundary		
Distinctness	Gradual	
Topography	Irregular	
Consistency		
Dry	Slightly Hard	
Moist	Friable	
Completion		
Overall Findings	<p>Based on today's site investigation, the site is ideal for our project and there are no foreseeable risks aside from the fire risk west of the city (California fires 2018). Visual inspection do not show soil contamination and no nearby industrial activities. Will still wait for the result of the lab testing of soil samples to be conclusive for the geotechnical report.</p>
