Food Processing Corp / 26 Apr 2019 / John West

PSSR Checklist Conducted on 26th Apr, 2019 By SafetyCulture Staff

Equipment/Facility	New equipment
Equipment name	Industrial meat grinder
Location of Equipment	Room 1-A of building A
PSSR Team Members	John W.

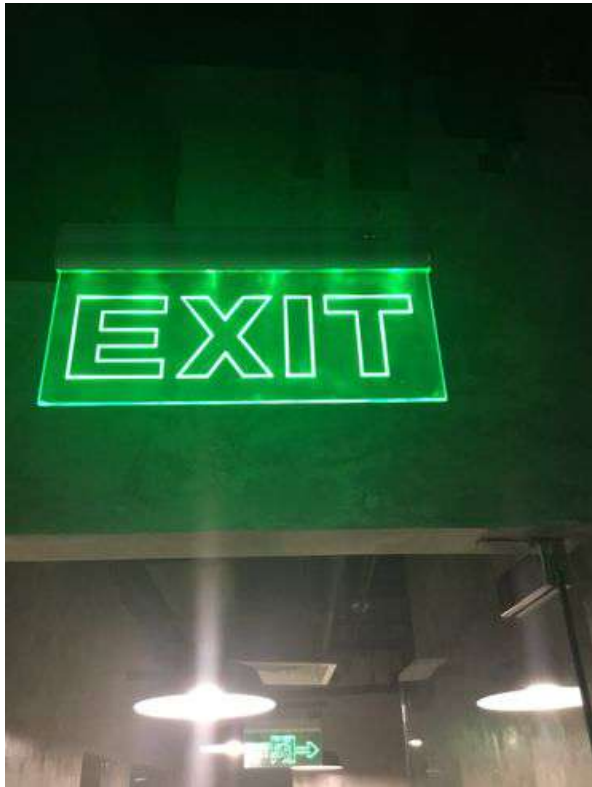
Photo 1

Have exit routes been rerouted if necessary?	N/A
Have employees been trained in new exit routes?	No
Has the emergency evacuation drawing been updated?	N/A
Is head room at least 7 feet high with no overhead obstructions below 6'8"?	Yes
Have all emergency exits been designated by appropriate signage/lighting?	Yes
<p>Notes</p> <p>New exit signs installed after a previous check determined lack of visible exit signs.</p> <p>Photos</p>

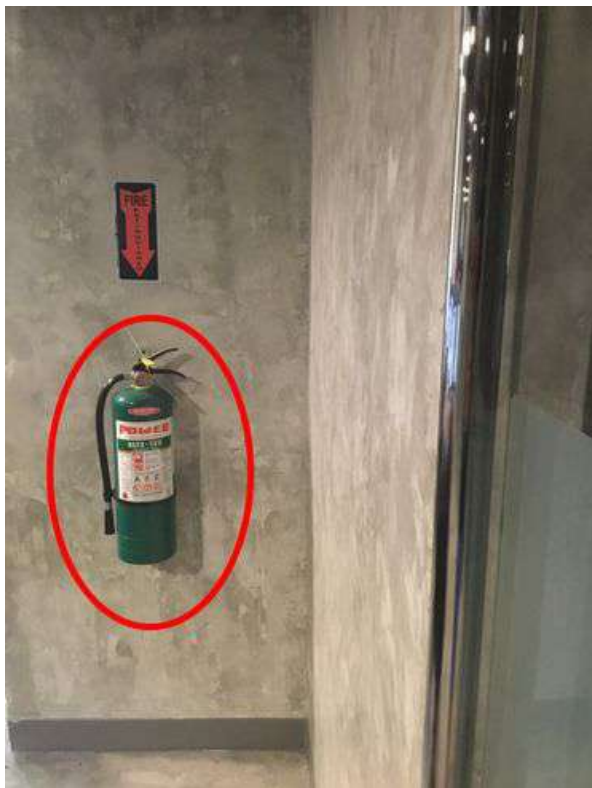
Photo 3

<p>Photo 2</p>	
Fire Extinguisher accessible and adequately marked?	Yes
<p>Notes</p> <p>Fire extinguisher installed on a visible corner.</p> <p>Photos</p>

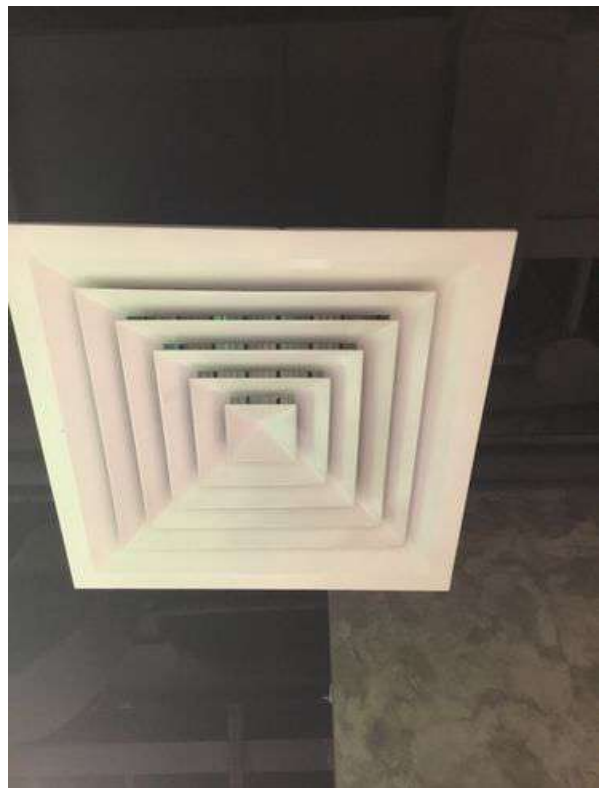
Photo 4

Does the new equipment generate hazardous vapors/gasses/fumes which will require additional ventilation?	Yes
Has ventilation been installed?	Yes
Notes The new equipment required ventilation.	
Photos

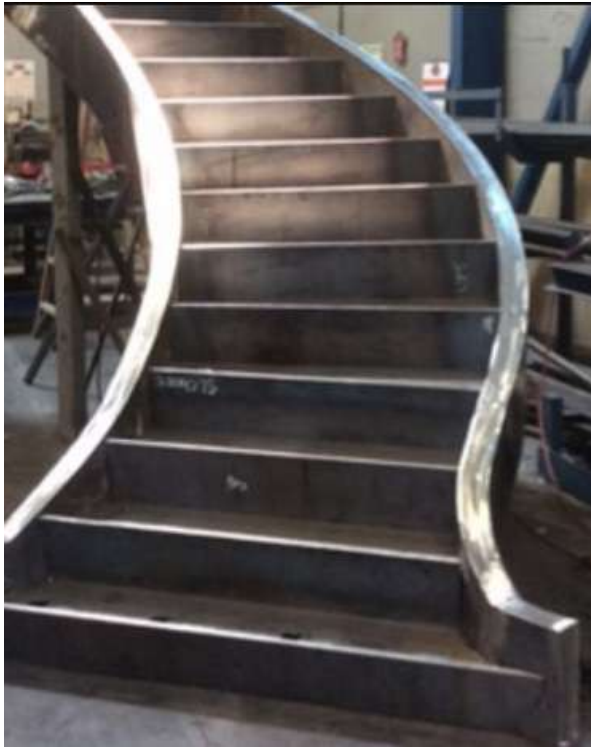
Photo 5

The new equipment will not create a situation in which employees must work more than 4' above the floor and outside of a standard guard rail?	No
<p>Notes</p> <p>New industrial meat grinder installed near old stairs that do not have guard rails. New stairs with guard rails installation task assigned to the facilities team and expected to complete during the weekend. See attached photo of old and new stairs.</p> <p>Photos</p> <div style="display: flex; justify-content: space-around;">

<p>Comments/Recommendations</p> <p>Stairs with guard rails need to be installed A.S.A.P. Heard about the horrific accident about a grinder in another facility earlier this week and we do not want that happening here. Apart from the new stairs, the rest are good to go. We did well on the new ventilation, visible exit signs, and that fire extinguisher on the visible and very accessible corner.</p>	
Safe and ready for commissioning/startup?	No
