Davidson Corp. / Manufacturing / Dylan Byers / 21 May 2019

Basic Hazard Identification Template Conducted on 21st May, 2019 By SafetyCulture Staff

Failed items	Created actions
2	1
Department / Area of work Davidson Corp. / Manufacturing	
Date of Inspection 📅 21st May, 2019 ⌚ 9:50 AM +08	
Conducted by Dylan Byers	
Location Arvada, WY 82831, USA

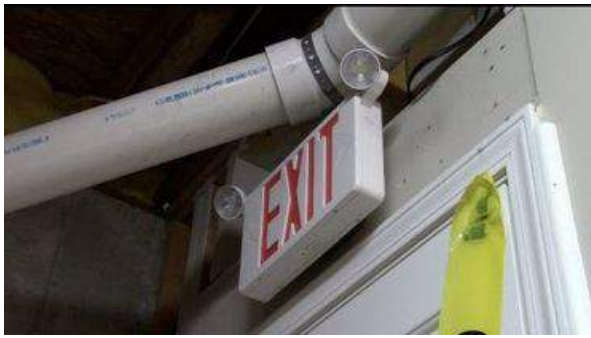
Photo 1

Specify hazard Exit sign	
Hazard type	Safety hazard
Describe hazard Exit sign doesn't turn on when tested	
Risk rating	Serious
Notes Exit signs must be properly illuminated by a reliable light source, with a minimum of 5 foot-candles on the illuminated surface.	
Actions	To Do See what's wrong and perform necessary actions
Take or attach photo of hazard	
Photos

Risk rating	Serious
Notes Exit signs must be properly illuminated by a reliable light source, with a minimum of 5 foot-candles on the illuminated surface.	
Actions	
To Do See what's wrong and perform necessary actions

See what's wrong and perform necessary actions

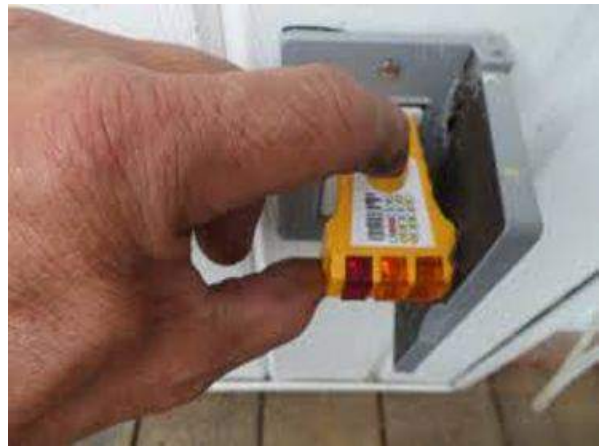
Photo 2

Specify hazard Shock hazard	
Hazard type	Other
Please specify Electrical hazard	
Describe hazard possible shock hazard from outlet #5-A in level 1 due to reversed polarity	
Risk rating	Serious
Take or attach photo of hazard	
Photos

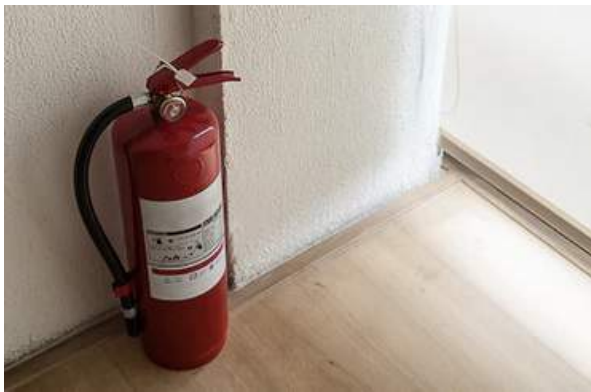
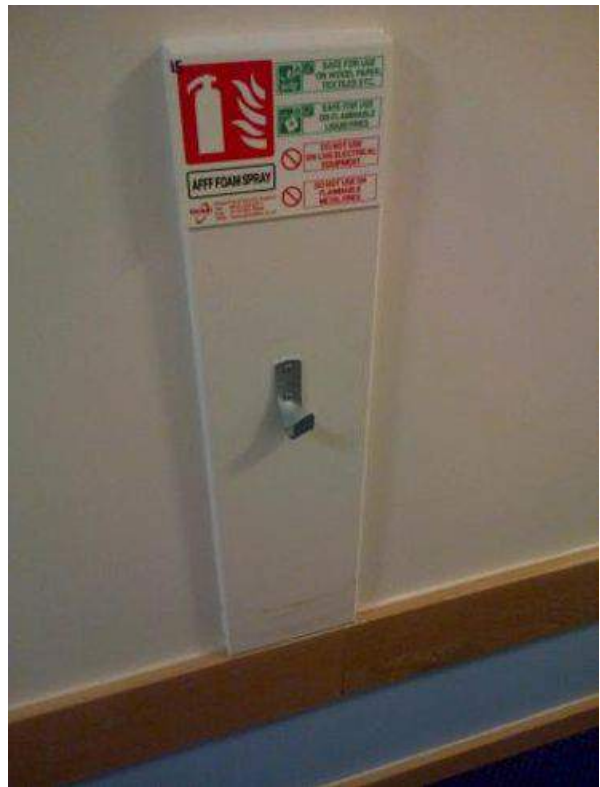
Photo 3

Specify hazard Fire extinguisher	
Hazard type	Safety hazard
Describe hazard Fire extinguisher #8 was found on the floor when it should be placed at its container	
Risk rating	Minor
Notes Already placed it on its respective place & additionally conducted a fire extinguisher inspection	
Take or attach photo of hazard	
Photos

Comments / Recommendations Overall, it was a good inspection. No major hazards were found but it is still important to bring utmost attention to the hazards identified above. Fire extinguisher has been examined so no need to conduct separate inspection.	
Name & Signature of Safety Inspector
