Asbestos Risk Assessment

Failed items <b>0</b>	Created actions <b>0</b>
Conducted on 📅 1st Aug, 2019 ⌚ 1:17 PM +08	
Prepared by Astrid North	
Location 1794 Cedar Ave Long Beach, CA 90813 United States (33.7883216596039, -118.1948125266709)

Description of procedure, task or worksite being assessed  
 New centre of operations

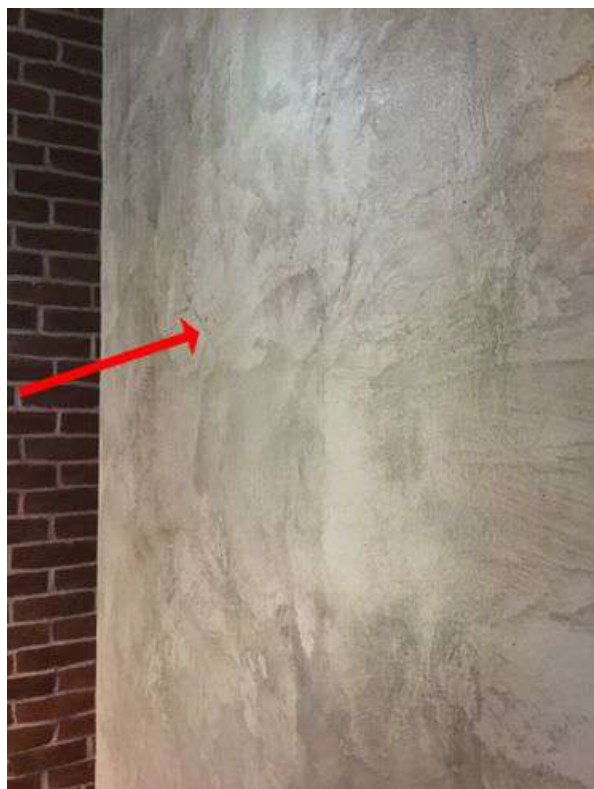
Photo 1

Description of hazard Suspected asbestos used in insulation of walls of old building being renovated.
Photo of hazard
– Photos

Consequences	Fatality
Likelihood	Very Likely
Risk Rating (refer risk matrix above)	High
Comments/ observations Wall is in good condition but the boss wants an asbestos free site.

Select control measures	Substitution
Explanation of controls	Substitution

Aside from the ceiling and walls, there are no other sign of asbestos. This building had been abandoned for a while before we took over and the previous occupant eliminated the other asbestos risk aside from the wall and popcorn ceiling. Sent action for taking care of the ceiling. We will handle the wall.

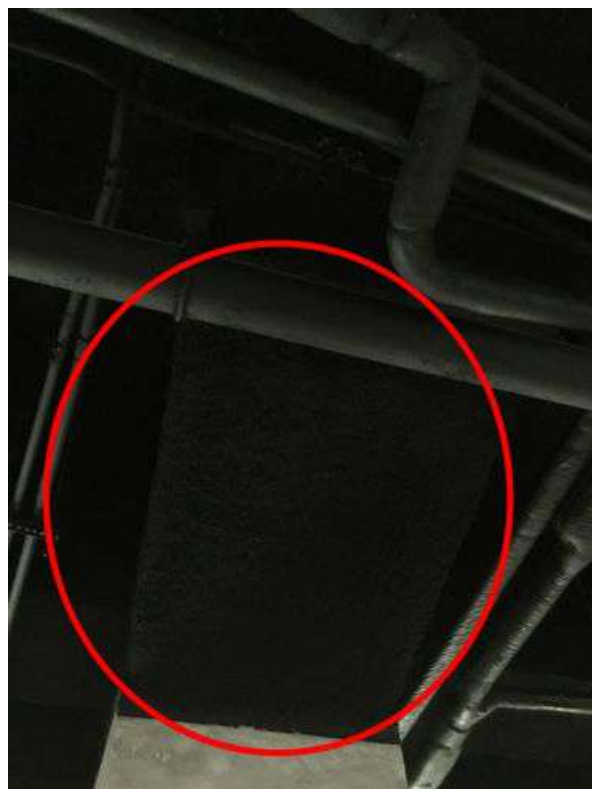
Photo 2

Description of hazard Popcorn ceiling in a building this old likely has asbestos.
--

Consequences	Fatality
Likelihood	Very Likely
Risk Rating (refer risk matrix above)	High
Comments/ observations Will need to get professional contractors to remove the popcorn ceiling and safety get rid of the asbestos.

Select control measures	Elimination
Explanation of controls	Elimination
