Safetyden Building Inc. / A-13345 / 25 Oct 2019

Ventilation Checklist

Inspection score	Failed items	Created actions
80.00%	4	2
Site Safetyden Building Inc.		
Ventilation number A-13345		
Date and Time of Inspection 📅 25th Oct, 2019 ⌚ 1:30 PM +08		
Inspector (Full Name) John Arcilie		
Location 5000 Estate Enighed, Independence, KS 67301, USA

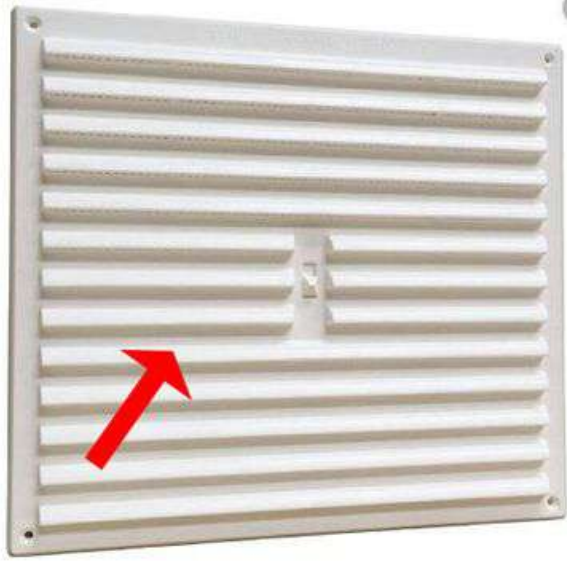
Photo 1

Have all background ventilators been left in the open position?	No
<p>– Notes</p> <p>There is a closed vent exhaust at bay 2</p> <p>– Photos</p>

Total installed equivalent area of background ventilators in dwelling? 5m3 / (h.m2)	
Total floor area of dwelling? 30,000 mm2	
Does the total installed equivalent ventilator area meet the requirements?	Yes
Have all background ventilators been left in the open position?	No
<p>– Notes</p> <p>There is a closed vent exhaust at bay 2</p> <p>– Photos</p>

<p>Recommendation</p> <ul style="list-style-type: none"> - Keep vent open at bay 2 - Check installation of vent covers at bay 3 - Fix the disturbing sound detected upon start up of ventilation systems 	
<p>Inspector (Full Name and Signature)</p> <div style="display: flex; align-items: center;"> <div style="border: 1px solid gray; border-radius: 10px; padding: 10px; margin-right: 20px;">

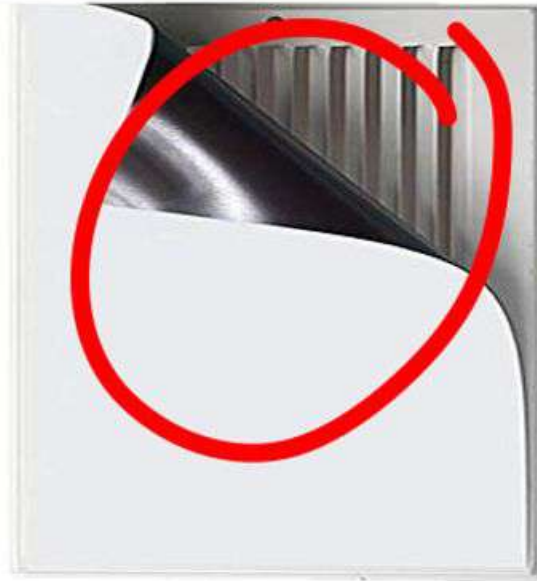
Photo 2

<p>Photo 1</p>	
Has all protection/packaging been removed such that the system is fully functional?	No
<p>– Notes</p> <p>Magnetic exhaust vent cover for bay 3 is not installed properly</p> <p>– Photos</p>

Has all protection/packaging been removed such that the system is fully functional?	No
<p>– Notes</p> <p>Magnetic exhaust vent cover for bay 3 is not installed properly</p> <p>– Photos</p>

<p>Photo 2</p> <p>– Actions</p> <p>To Do Hi James, can you check and fix this ventilation cover</p>	
Upon initial start-up, was any abnormal sound or vibration experienced, or unusual smells detected?	Yes
<p>– Notes</p> <p>Abnormal sound was detected upon start up</p> <p>– Actions</p> <p>To Do Hi Chris, Please check.</p>

Hi James, can you check and fix this ventilation cover
