Basic Asset Management Template

Score	60%	Flagged items	0	Actions	1
Date Created	27.04.2023 09:55 PST				
Company Name	PowerPrax, Inc.				
Prepared By	Voislav Hartmann				
Location	Kenora, ON P0V, Canada (49.7670416, -94.4893924)

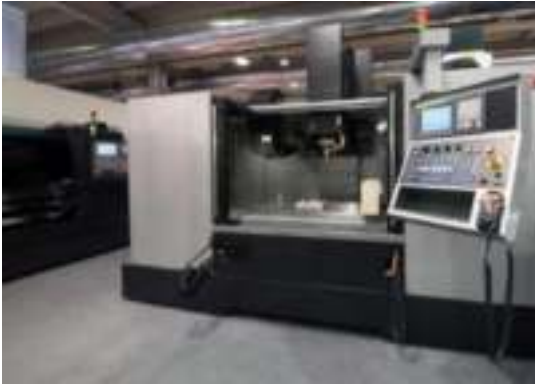
Photo 1

Asset Management	1 action, 60%
Asset	1 action, 60%
Asset 1	100%
Asset ID	001
Asset Name	CNC Milling Machine
Asset Type	Manufacturing Equipment
Asset Description	<p>This CNC milling machine is used to produce precision parts for the company's products. It has a high level of accuracy and efficiency, allowing for faster production times.</p>
Asset Photo(s)

<p>Photo 1</p>
Date of Acquisition	06.01.2020
Asset Value	\$250,000
Site/Location	Manufacturing Plant A
Asset Owner	Manufacturing Department
Asset Custodian	Steffie Beirne
Asset Condition	Very Good Condition
Only normal maintenance required	
Date of Last Maintenance	03.03.2023
Maintenance Schedule	
Maintenance Schedule 1	
Maintenance Activity	Cleaning and lubrication of machine parts
Frequency	Weekly

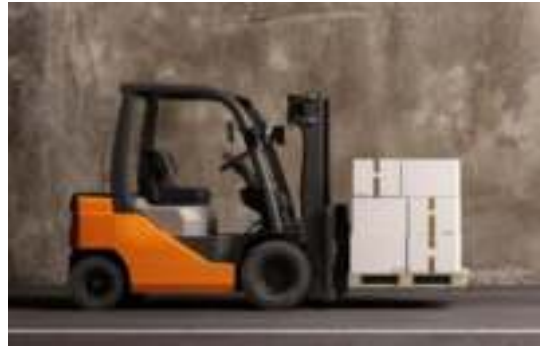
Photo 2

This forklift is used to move heavy materials and products around the manufacturing plant. It has a maximum lifting capacity of 5,000 pounds and is powered by propane.

Minor Defects Only

The hydraulic hoses are quite dusty and may require cleaning. Other than that, the forklift is working properly.

Minor maintenance required (5%)

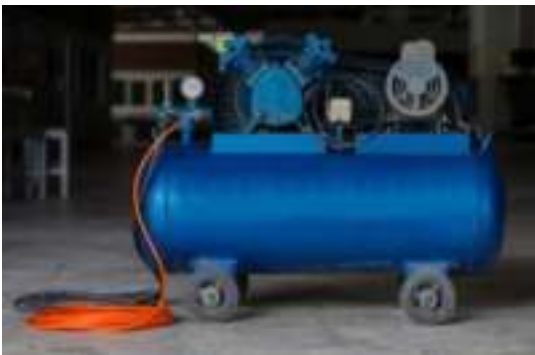
Photo 3

This air compressor provides compressed air for various tools and equipment used in the manufacturing process. It has a maximum pressure of 150 psi and a capacity of 50 gallons.

Date of Acquisition	14.03.2022
Asset Value	\$5,000
Site/Location	Manufacturing Plant C
Asset Owner	Facilities Department
Asset Custodian	Gerlind Johnson
Asset Condition	Renewal Required

Significant renewal/upgrade required (20-40%)

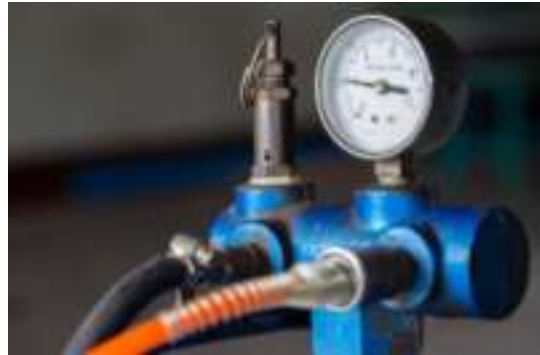
Photo 4

Description of the problem

The valves are worn from continuous use. Needs replacement ASAP.

To Do | Assignee SafetyCulture Staff | Priority High | Due 05.05.2023 10:10 PST | Created by S afetyCulture Staff

Replace worn valves from the air compressor ASAP.
