Roof Safety Inspection

The Net Group

TNG-143

35 Spring Gardens, Westminster, London SW1A 2BA, UK

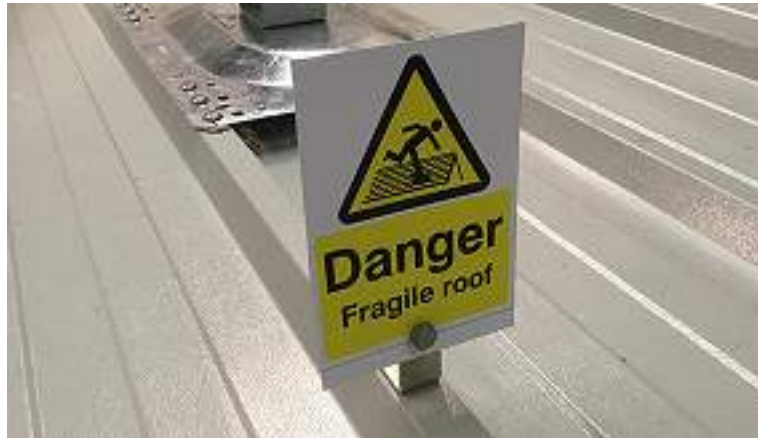
REFERENCE: Proper signage display
 [This is an example of how you can use iAuditor to include best practice reference images in your templates to assist with inspections]
