Trench or Excavation Daily Inspection

EXC-482201

Ridgemont Drainage System

1419-1421 Ridgemont Dr, Austin, TX 78723, USA

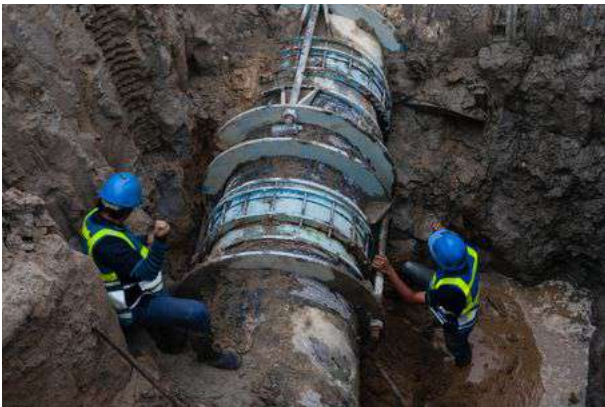
Appendix 7

Question	Response	Details
Wet Conditions		Score (4/4) 100.00%
Precautions take to protect employees from the accumulation of water.	Yes

<p data-bbox="140 577 256 607">Appendix 7</p>		
Water removal equipment monitored by a competent person.	Yes	
Surface water or runoff diverted or controlled to prevent accumulation in the excavation.	Yes	
Inspections made after every rainstorm or other hazard-increasing occurrence.	Yes	
Hazardous Atmosphere		Score (6/7) 85.71%
Atmosphere within the excavation tested where there is a reasonable possibility of an oxygen deficiency, combustible or other harmful contaminant exposing employees to a hazard.	No	A gas pipe was found upon excavation.
