16 Apr 2019 / EECU322406 / Expert Exporters Co.

ISO Container Inspection Checklist Conducted on 16th Apr, 2019 By SafetyCulture Staff

Inspection score	Failed items	Created actions
87.67%	9	3
Site Sydney		
Shipper Expert Exporters Co.		
Country of Origin United States of America		
Container Number EECU322406		
Inspected by Sabrina Diaz		
Conducted on 📅 16th Apr, 2019 ⌚ 12:18 PM +08

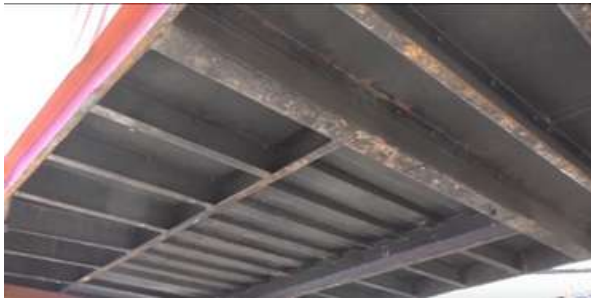
Photo 1

Corner fittings	Pass
Bottom end rails Notes Still in good condition. Photos

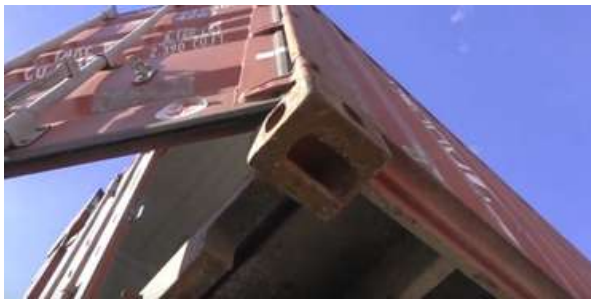
Photo 3

Photo 2 Actions <div data-bbox="204 1317 1390 1406">To Do Follow up condition of undercarriage side rail on next ISO container inspection (possible need for repair)</div>	Fail
Door sill Photos

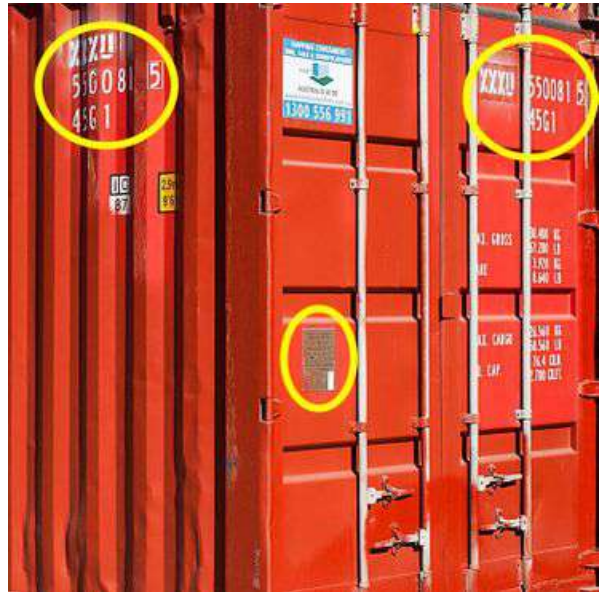
Photo 4

<p>Photo 4</p>	
CSC safety approval	Pass
Stencils	Pass
Corner posts	Pass
Corner fittings	Pass
Door header	Pass
Door sill	Fail
<p>Notes</p> <p>Monitor minor damage</p> <p>Photos</p>

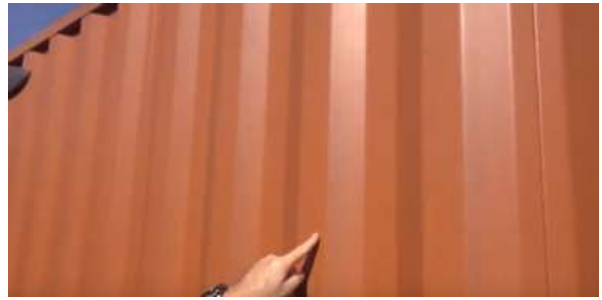
Photo 10

Plywood lining	Pass
Kick rail	Pass
Vertical plate	Pass
Horizontal rail	Pass
Light leak	Pass
