BO's Tires / Chloe Hughes / 09 Oct 2019

Product Evaluation Template

Product Being Tested Bo's Truck Tires	
Add Photo	
- Photos

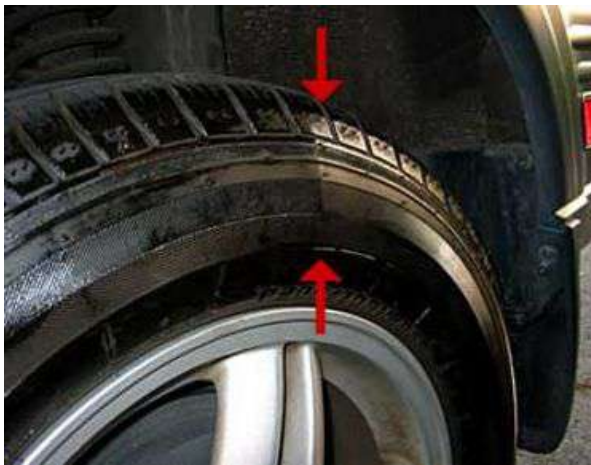
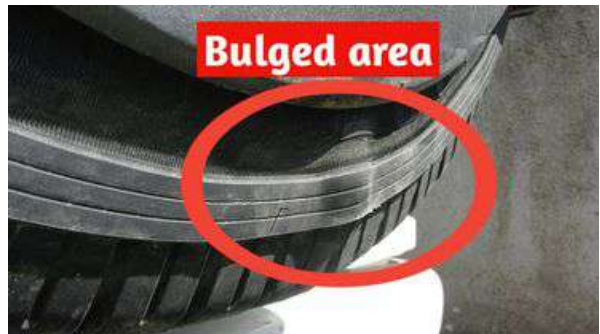
Product is free of damage	No
- Notes Noticed some bulges among the tires produced awhile ago	
- Photos

With the number of manufacturing issues identified in batch 1 of production and in previous batches, I'm marking this as unacceptable as it goes against all our product standards. Certain corrective measures must be implemented to reduce manufacturing defects. This product batch will not be released to market.

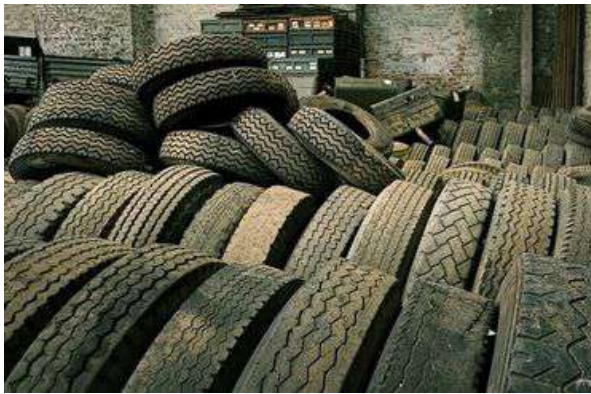
Photo 5

Product is free of deterioration	No
<p>– Notes</p> <p>Inspected tire storage and observed a number of prematurely deteriorated tires.</p> <p>– Photos</p> <div data-bbox="194 1014 422 1238">

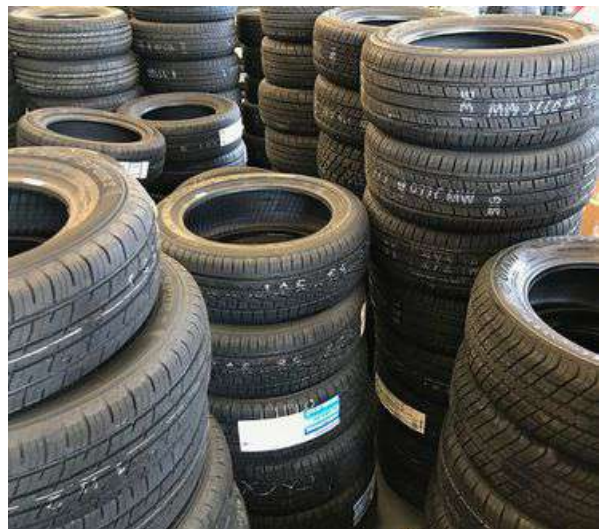
Photo 6

Detailing is appropriately clear	No
<p>– Notes</p> <p>Detailing is appropriate however some prints on tires are unclear</p> <p>– Photos</p> <div data-bbox="194 1765 422 1989">

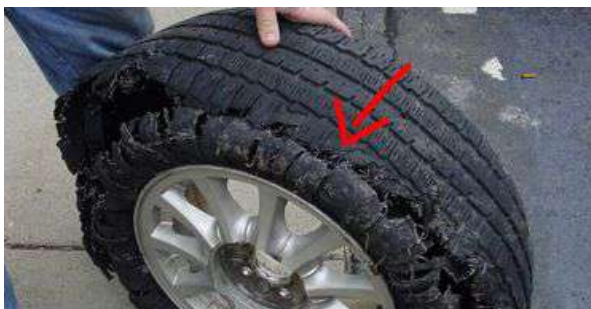
Photo 7

Additional defect found Tread Separation
Description of the defect A manufacturing defect found on one of the tires in batch 1 of today's production.
Add photo of defect
<p>– Photos</p>
